**Attachment to Funding Determination Request**

**Narrative Responses to Section IV, Questions 1, 2, 3**

# Mold Inspection Report

## Microbial Investigation

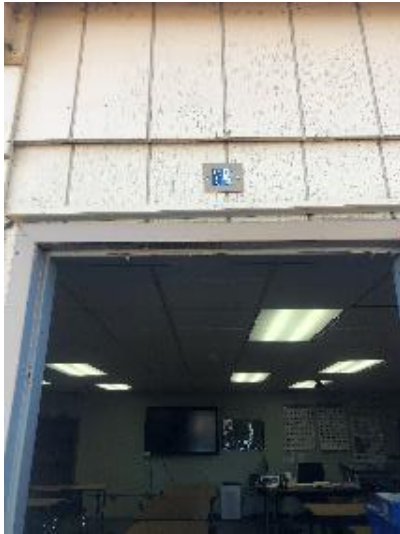
**Photo #1:**

Visible water damage found on ceiling tiles.  
 -Suspect mold growth found on right wall (wall faces bathroom). Precautionary surface samples taken to determine possible contamination.

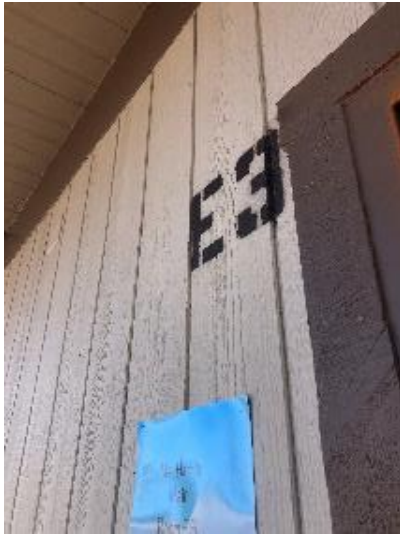
**Photo #1:**

No visible suspect mold growth or elevated moisture found at the time of inspection. Precautionary surface sample taken to determine possible contamination.
