**Attachment to Funding Determination Request**

**Narrative Responses to Section IV, Questions 1, 2, 3**

# Mold Inspection Report

## Microbial Investigation

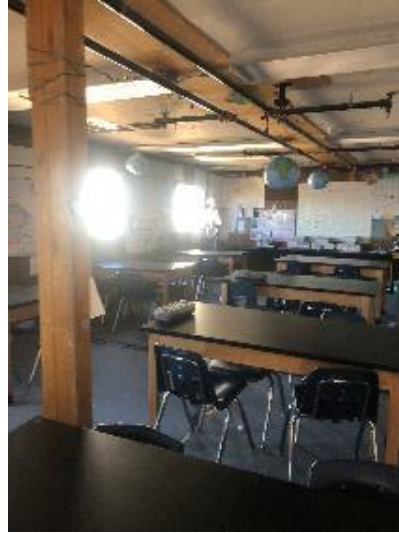
**Photo #2:**

Visible water damage found on ceiling tiles. Precautionary surface samples taken to determine possible contamination.

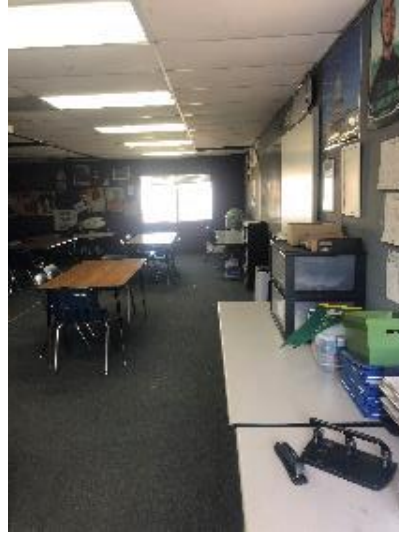
**Photo #2:**

- Suspect mold growth and visible water damage found on walls. Precautionary surface samples taken to determine possible contamination.
- Visible water damage found on ceiling tiles.

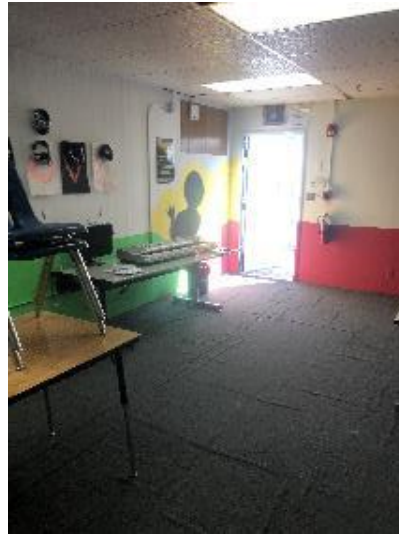
**Photo #2:**

Visible water damage found on back wall .Precautionary surface samples taken to determine possible contamination.

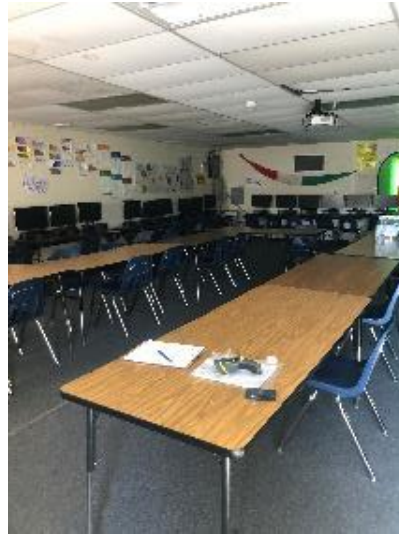
**Photo #2:**

-Suspect mold growth and visible water damage found on ceiling tiles. Precautionary surface samples taken to determine possible contamination.

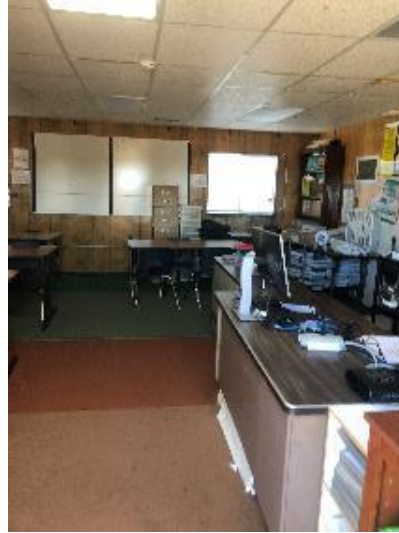
**Photo #2:**

Suspect mold growth and visible water damage found on back wall. Precautionary surface samples taken to determine possible contamination.  
-Visible water damage found on left and front wall.

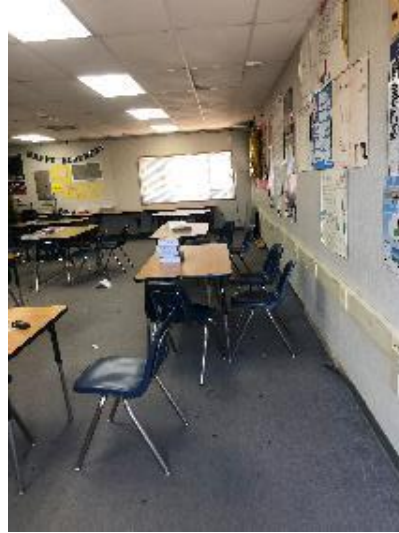
**Photo #2:**

-Suspect mold growth and visible water damage found on ceiling tiles. Precautionary surface samples taken to determine possible contamination.

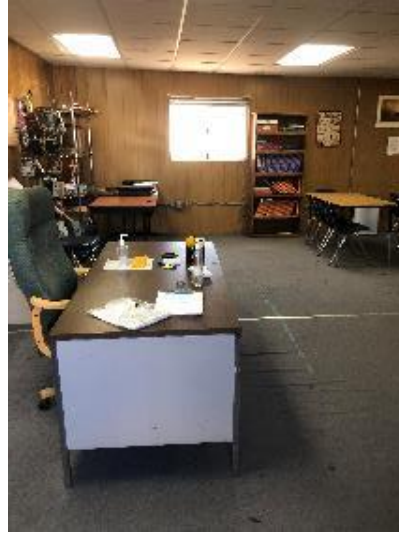
**Photo #2:**

- Visible water damage found on ceiling.
- Suspect mold growth and visible water damage found left and front wall. Precautionary surface samples taken to determine possible contamination.
- Suspect mold growth and visible water damage found on back wall.

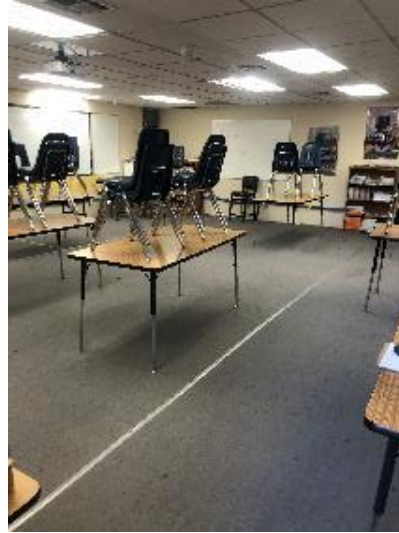
**Photo #2:**

-Visible water damage found on ceiling tiles. Precautionary surface samples taken to determine possible contamination.
