# INFORMATION BULLETIN

May 30, 2003

## **CARPENTER SCHOOL BUSES (POTENTIAL CRACKED, BROKEN OR MISSING WELDS)**

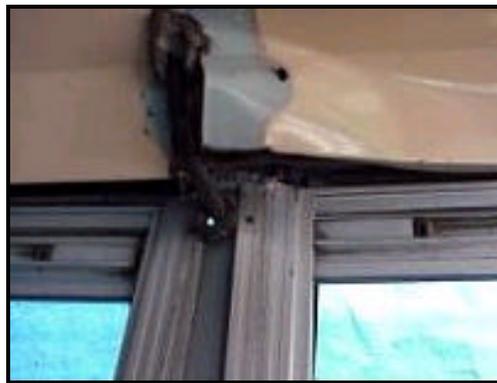
This information was developed through a recent collision in Florida involving a 1991 Carpenter Type 1 (transit style) school bus which rolled over, causing the roof to collapse down to the seat level. Fortunately, there were no children aboard at the time of the collision. Subsequent inspection of the bus discovered failure of a large percentage of structural welds in the roof. Additionally, inspections of Carpenter school buses in various parts of the country have revealed cracked and broken welds in the roof structures. This problem is clearly not confined to Florida, where it was first discovered.

The welds in question are located at the junction of the vertical side posts (between the windows) and the horizontal structural member (the "Carlin" rail) above the windows. Figure 1 illustrates the general location of potential defects (note: this figure shows damage done to the bus in Florida). Figure 2 illustrates the location of the panel that should be removed for inspection of possible cracked or broken welds. Both the left and right side panels should be removed.

Fig. 1. General Location of Potential Defect (shown on Florida bus)

**The CHP recommends that carriers operating Carpenter school buses manufactured in the Mitchell, IN plant during the years of 1986 to 1996 immediately inspect each vehicle for defects in the areas previously mentioned in this Information Bulletin.**

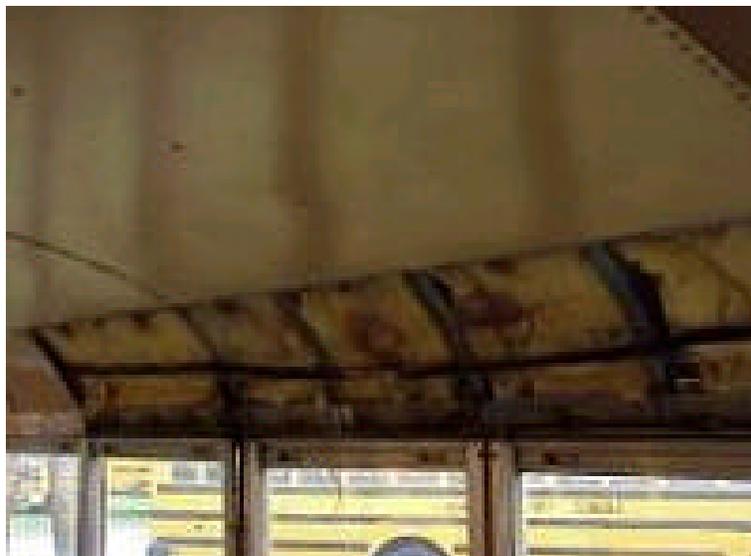
Fig. 2. Location of Interior Roof Panel Removed for Inspection Purposes

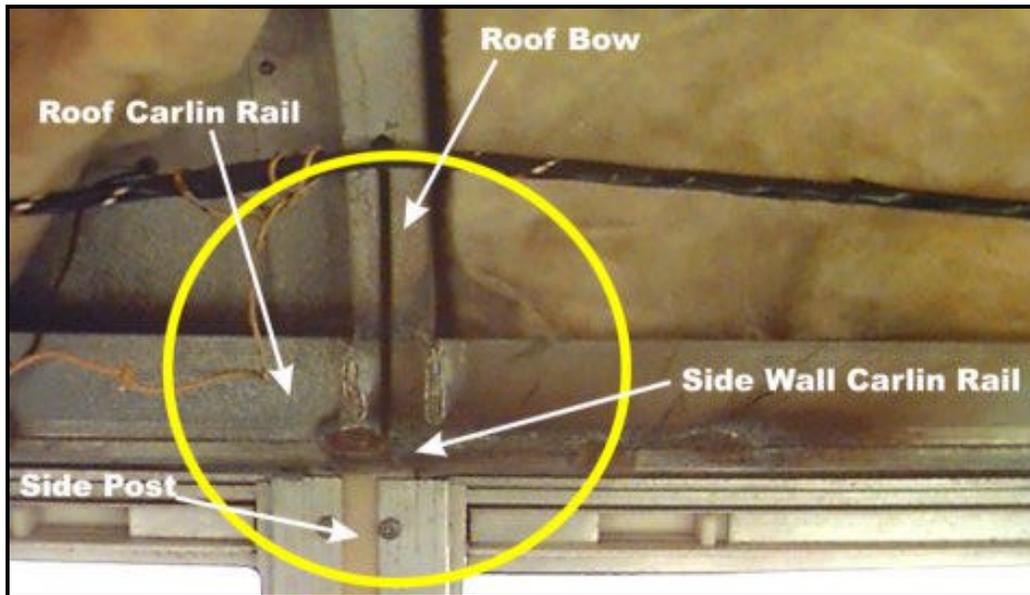
Figure 3 shows the locations of the components which include the Roof Bow, Roof Carlin Rail, Side Post and Side Wall Carlin Rail which are welded together to form the roof structure.

Fig. 3. Locations of Roof and Window Components which are Welded Together

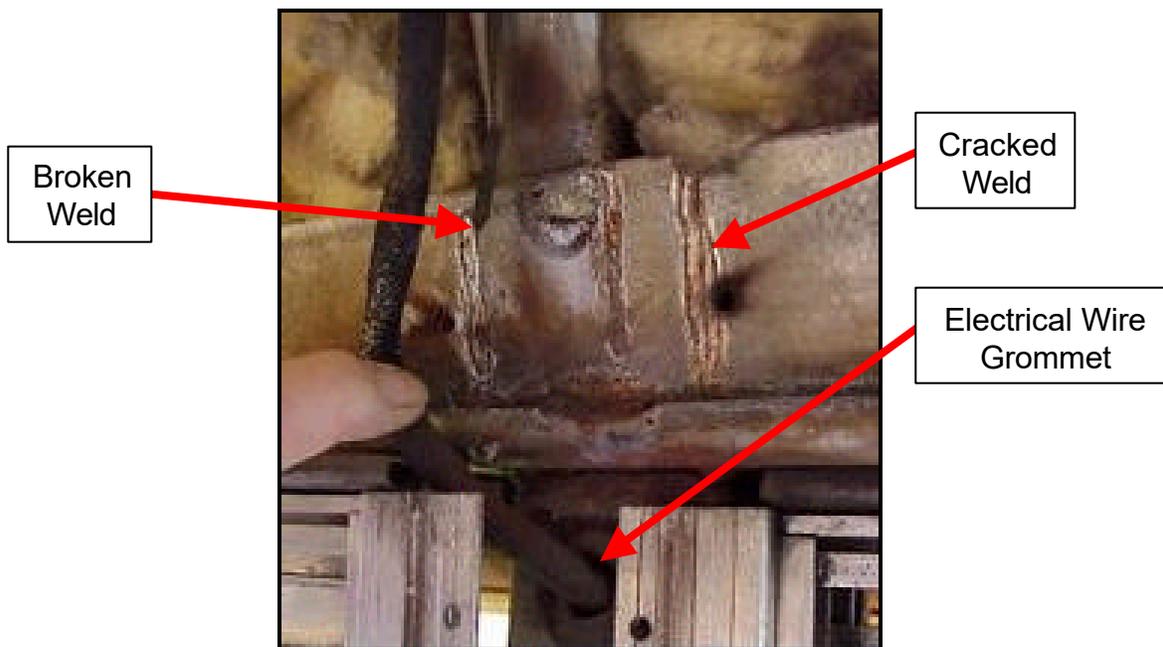
Fig. 4. Location of Broken Welds Approx. 1/2-inch Above Wire Grommet

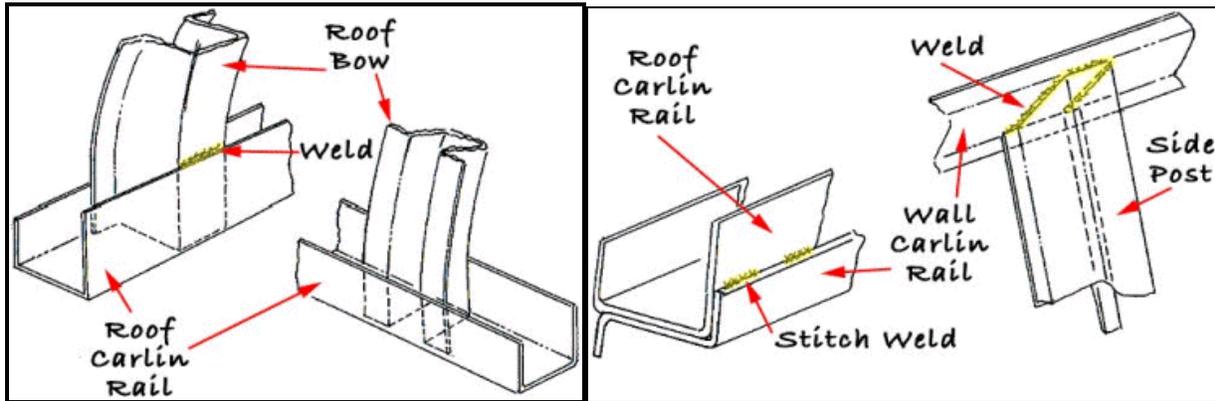
Figure 5 illustrates the location of welds between Roof Bow and Roof Carlin Rail and the location of welds and Stitch Welds between Side Post and Roof Carlin Rail where inspection personnel should look for cracked, broken or missing welds. Figure 6 shows the location of the Post-to-Floor Joint where the Post is seam-welded to the Floor Section.

Fig. 5. Location of Weld between Roof Bow and Roof Carlin Rail and Location of Weld and Stitch Weld between Side Post and Roof Carlin Rail

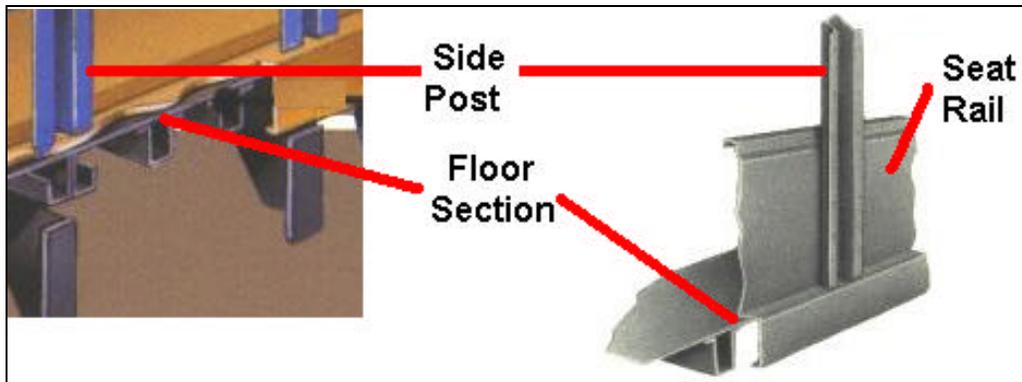
Fig. 6. Location of Weld between Post and Floor Section
