**Attachment to Funding Determination Request**

**Narrative Responses to Section IV, Questions 1, 2, 3**

# Mold Inspection Report

## Microbial Investigation

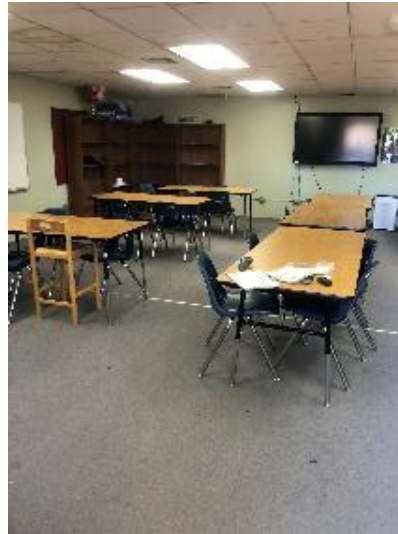
**Photo #2:**

Visible water damage found on ceiling tiles.  
 -Suspect mold growth found on right wall (wall faces bathroom). Precautionary surface samples taken to determine possible contamination.

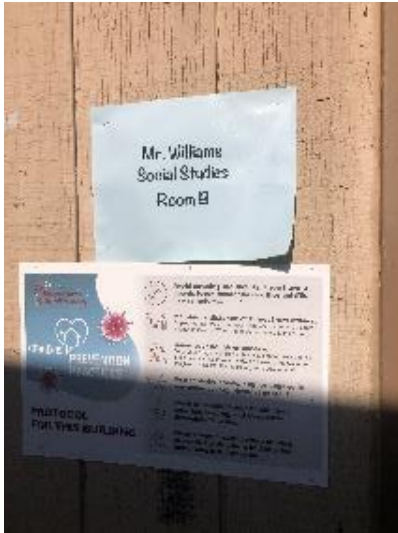
**Photo #1:**

- Visible water damage found on ceiling tiles.
- Suspect mold growth and visible water damage found on left and right wall. Precautionary surface samples taken to determine possible contamination.
