**Attachment to Funding Determination Request**

**Narrative Responses to Section IV, Questions 1, 2, 3**

# Mold Inspection Report

## Microbial Investigation

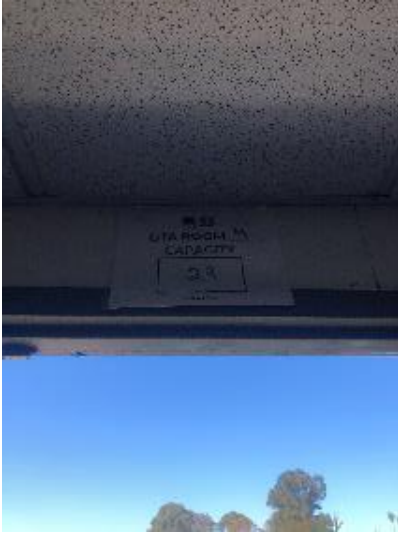
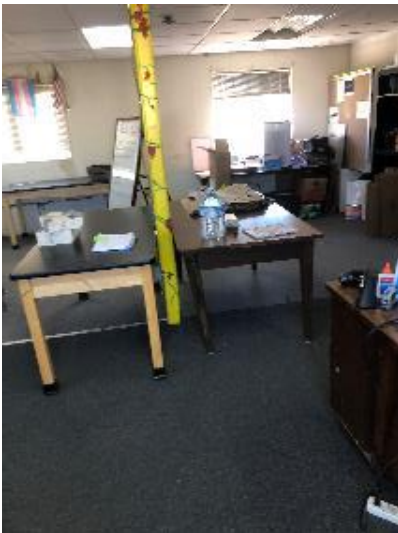
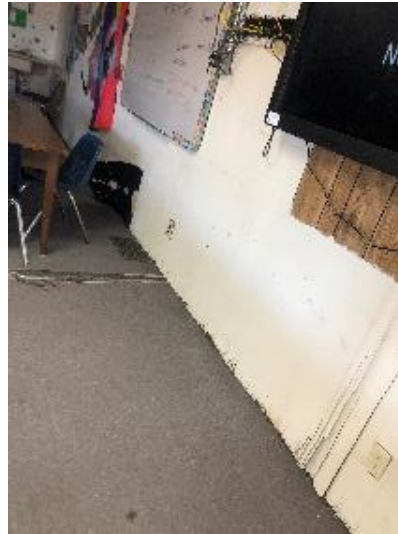
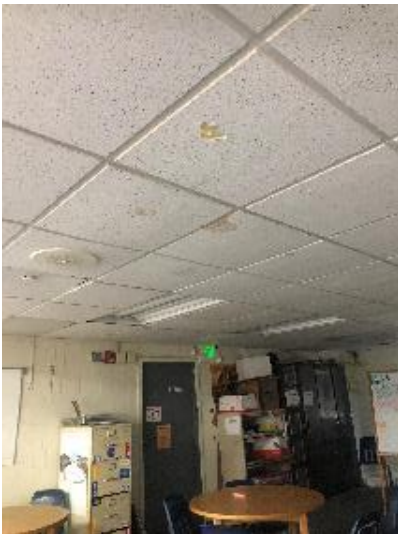
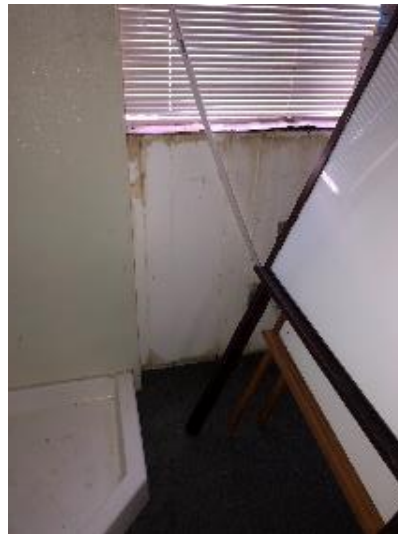
**Location #2 - Photographs**

- Visible water damage found on ceiling tiles.
- Suspect mold growth and visible water damage found on front and back wall. Precautionary surface samples taken to determine possible contamination.

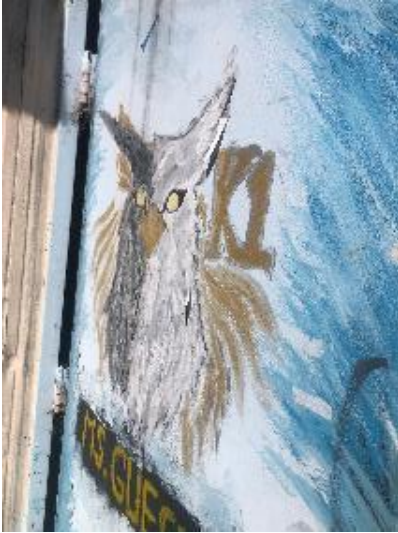
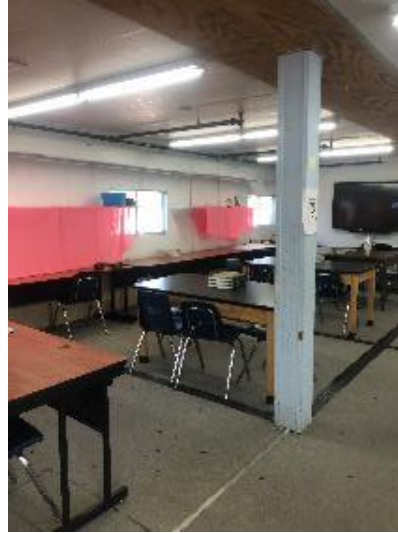
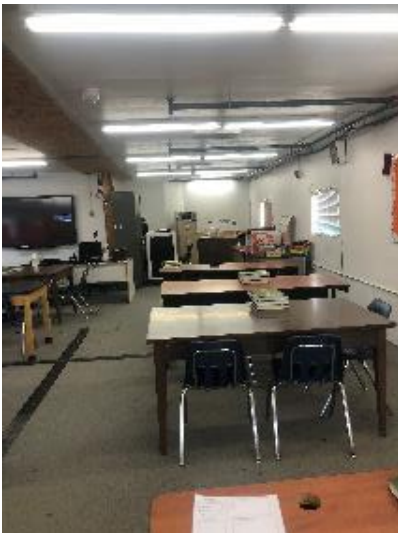
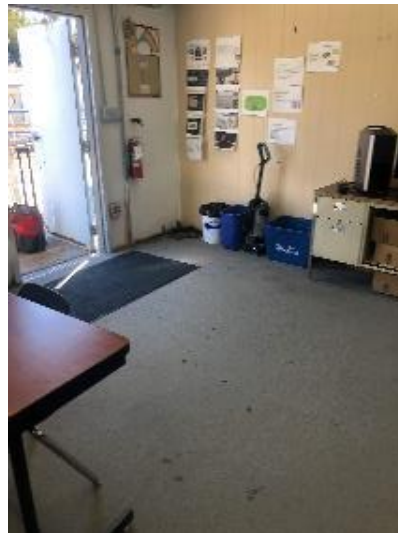
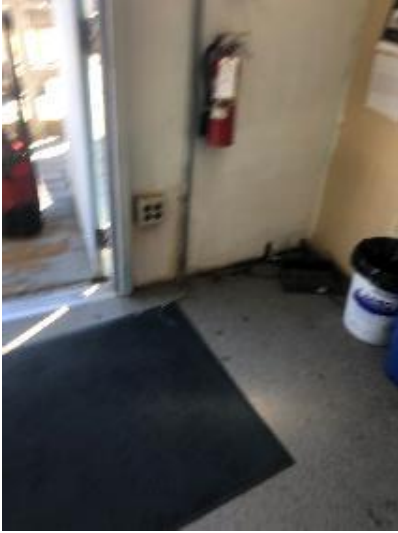
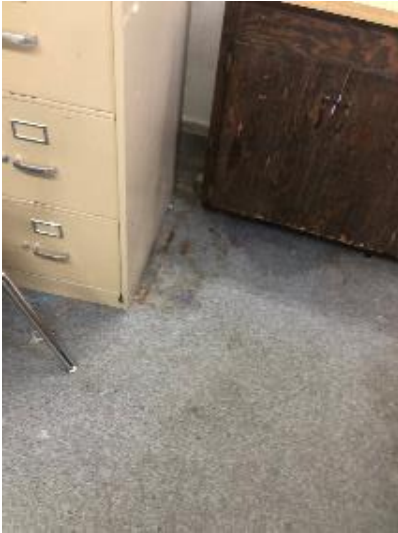
**Location #3 - Photographs**

Visible water damage found on ceiling tiles. Precautionary surface samples taken to determine possible contamination.

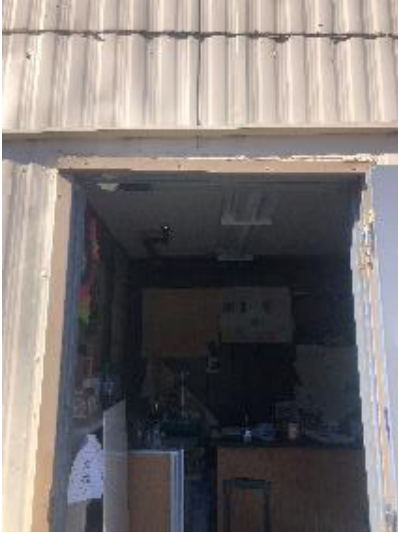
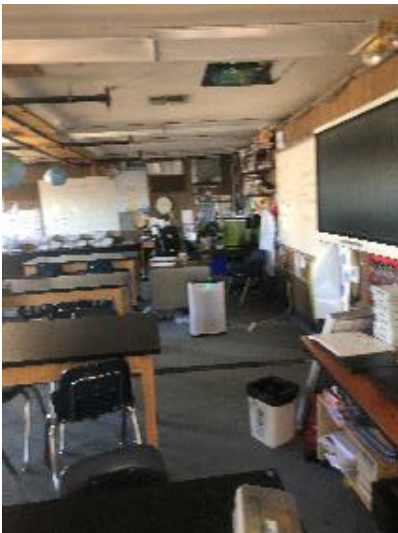
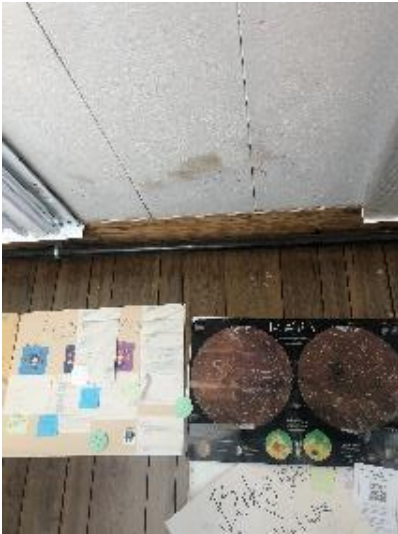
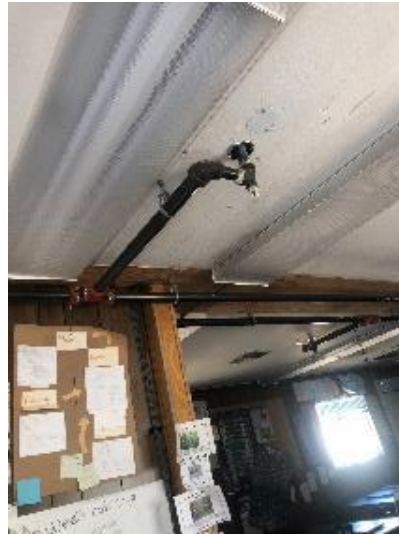
**Location #4 - Photographs**

- Suspect mold growth and visible water damage found on walls. Precautionary surface samples taken to determine possible contamination.
- Visible water damage found on ceiling tiles.

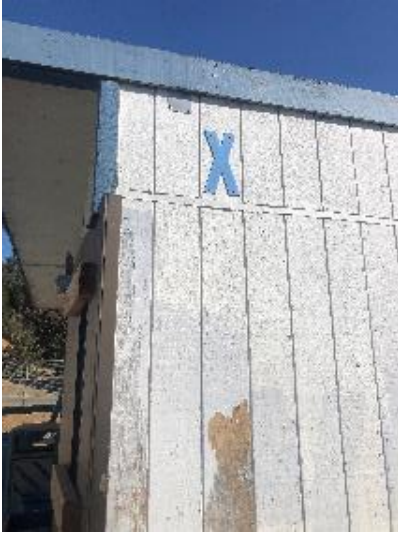
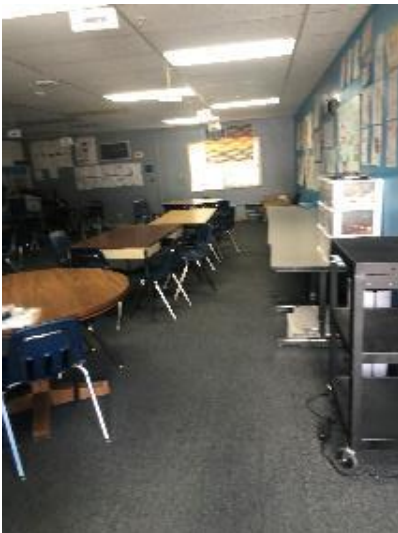
**Location #6 - Photographs**

Visible water damage found on back wall .Precautionary surface samples taken to determine possible contamination.

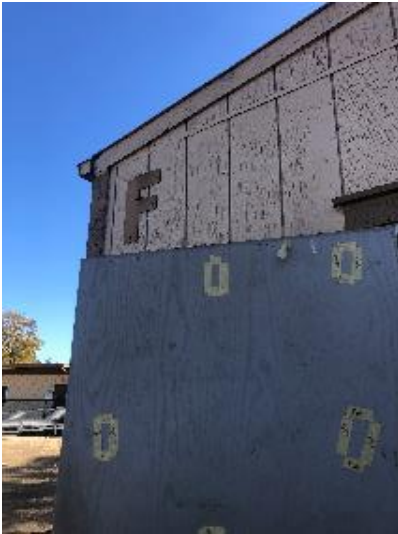
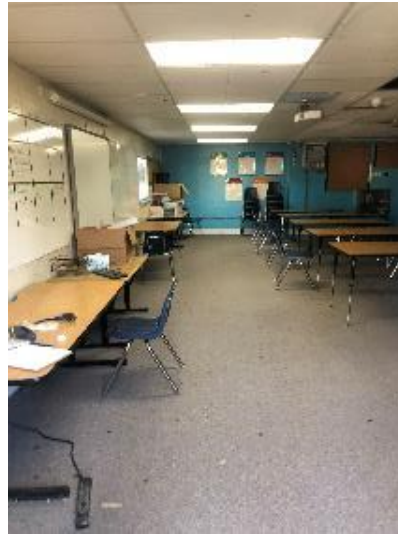
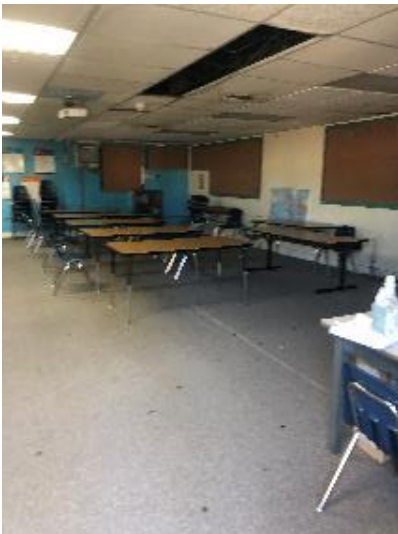
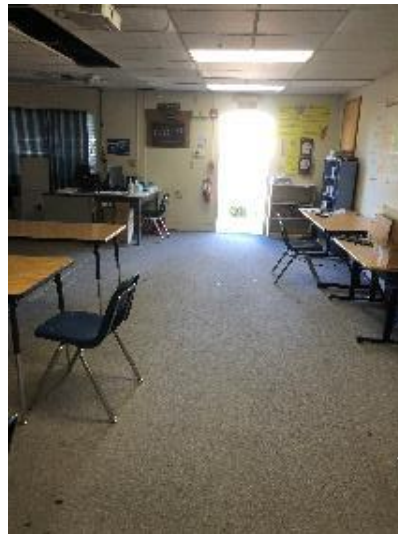
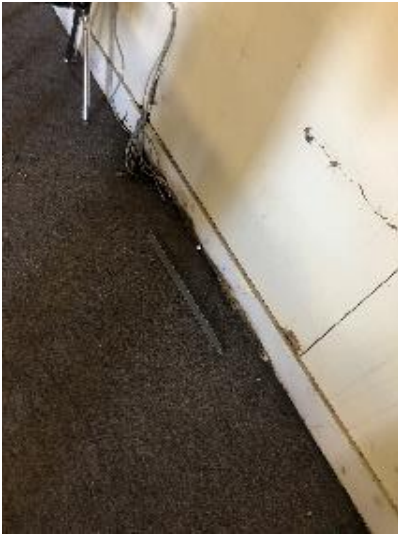
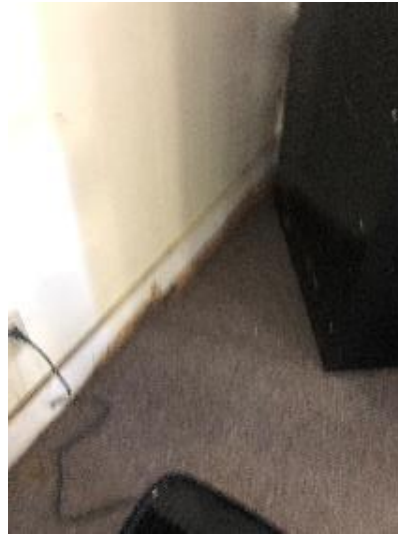
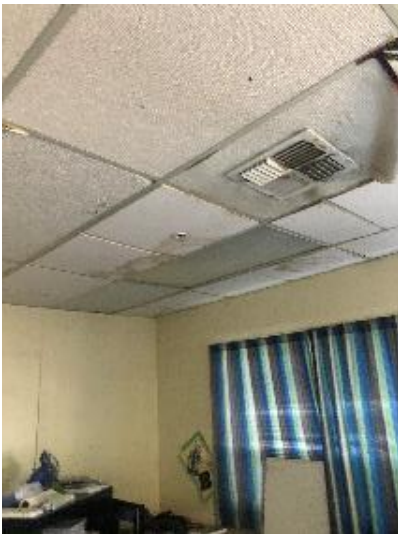
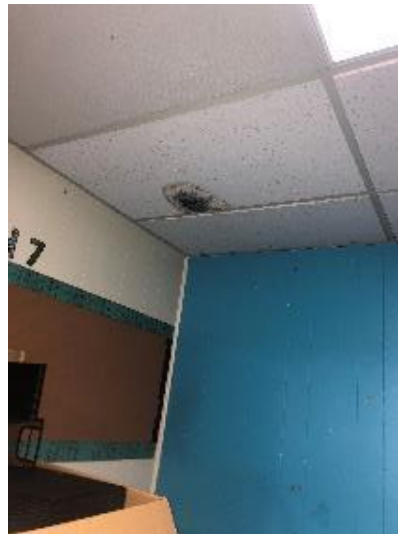
**Location # 8 - Photographs**

-Suspect mold growth and visible water damage found on ceiling tiles. Precautionary surface samples taken to determine possible contamination.

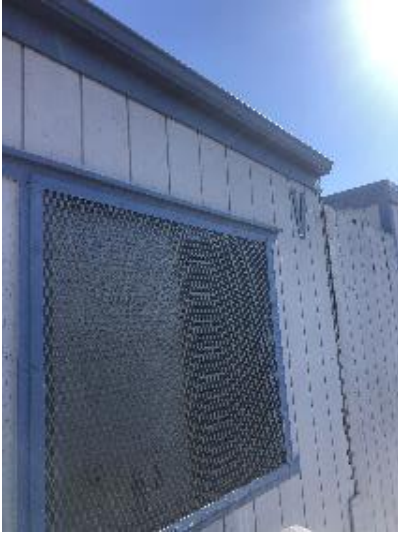
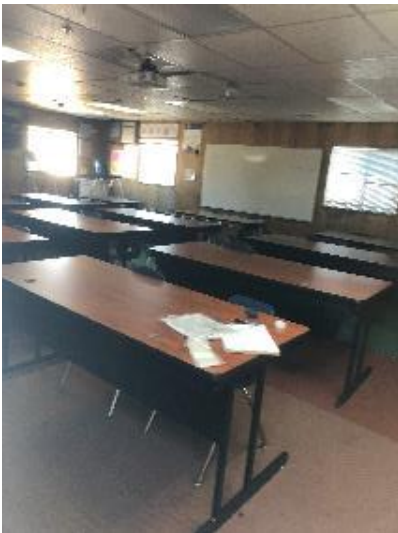
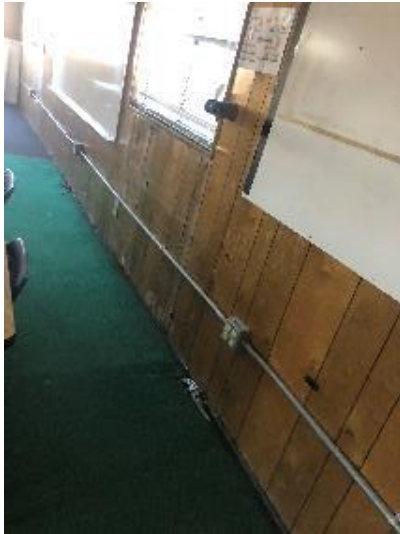
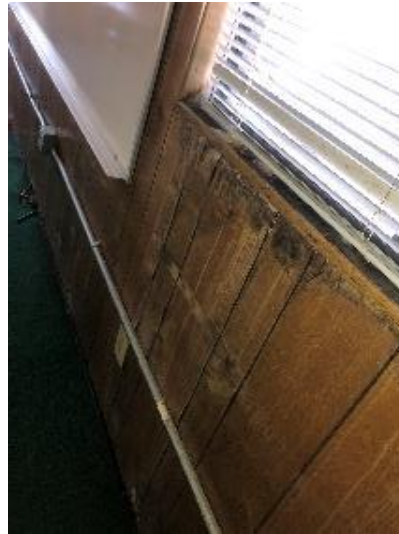
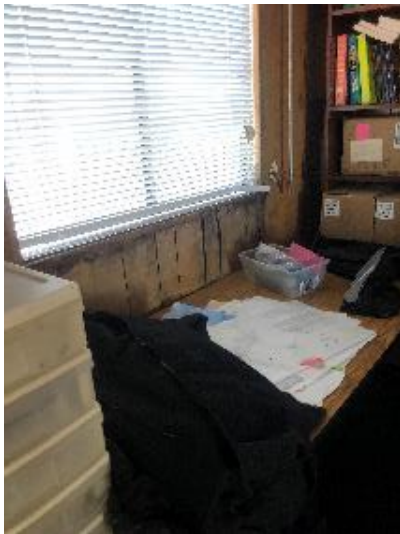
**Location #10 - Photographs**

Suspect mold growth and visible water damage found on back wall. Precautionary surface samples taken to determine possible contamination.  
-Visible water damage found on left and front wall.

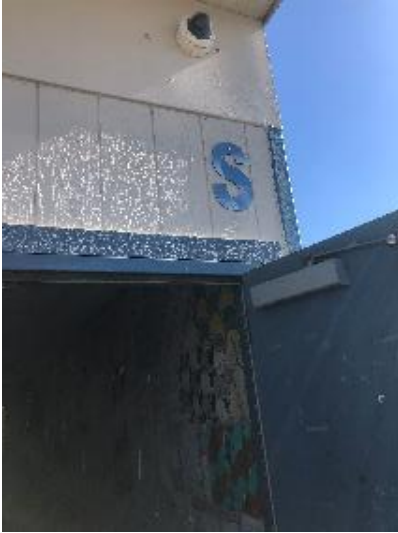
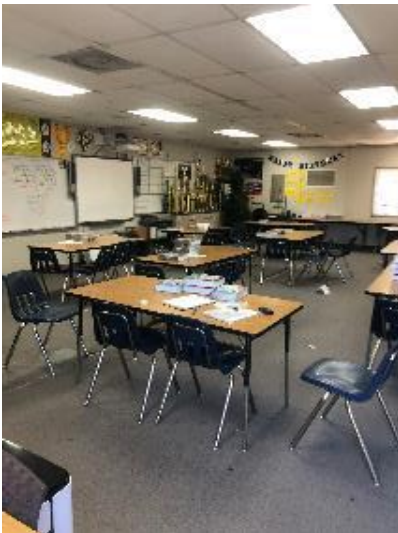
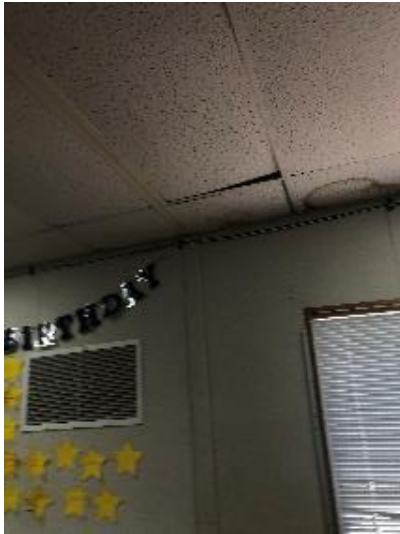
**Location #11 - Photographs**

-Suspect mold growth and visible water damage found on ceiling tiles. Precautionary surface samples taken to determine possible contamination.

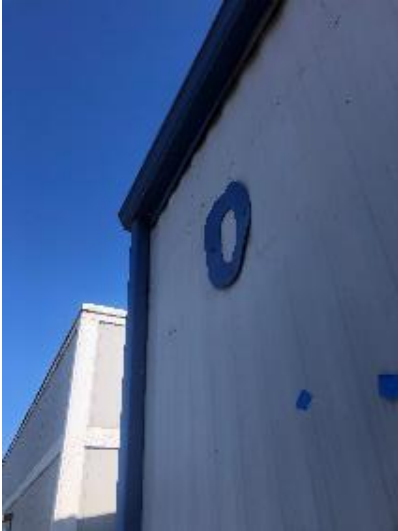
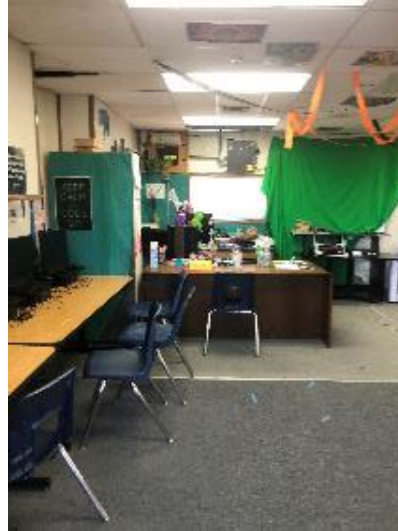
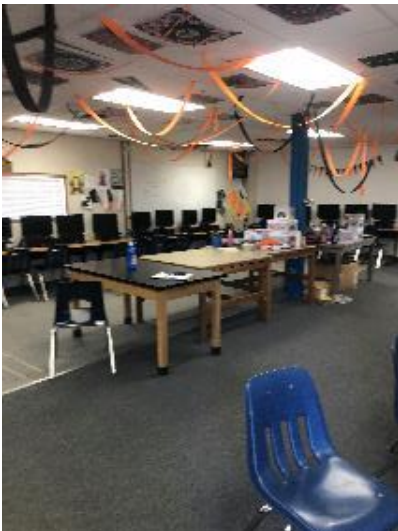
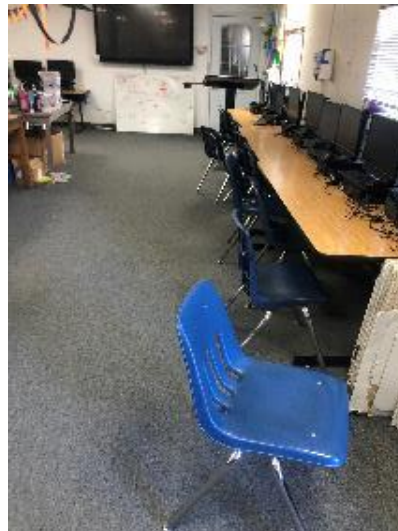
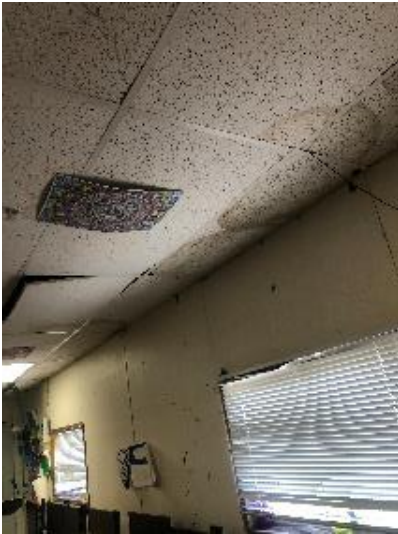
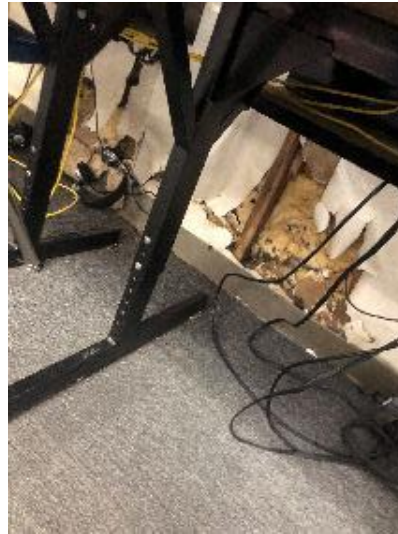
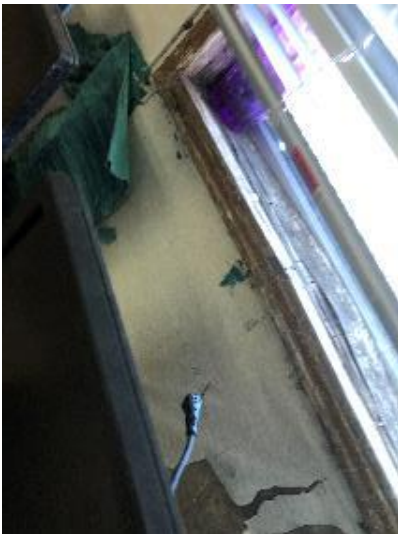
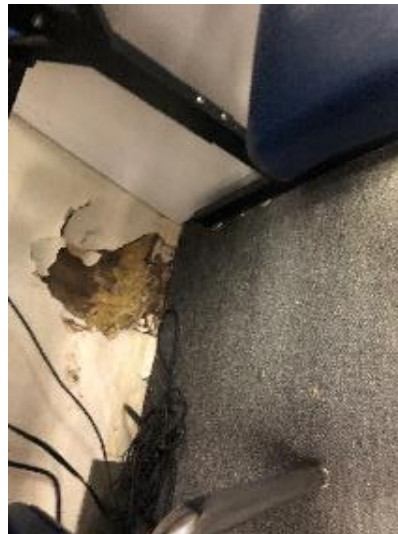
**Location #12 - Photographs**

- Suspect mold growth and visible water damage found on front and back wall. Precautionary surface samples taken to determine possible contamination.
- Suspect mold growth and visible water damage found on ceiling.
- Visible water damage found around window frame.

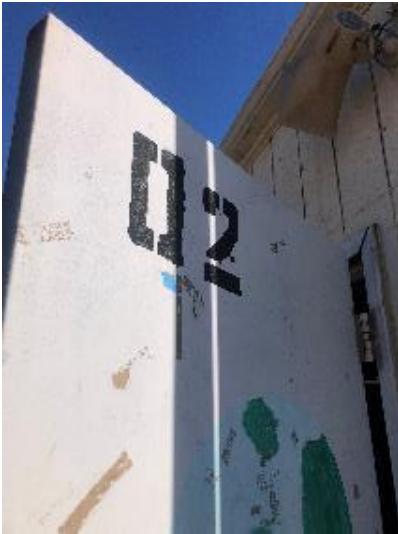
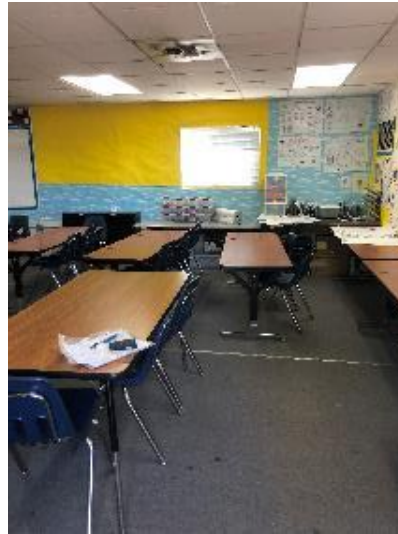
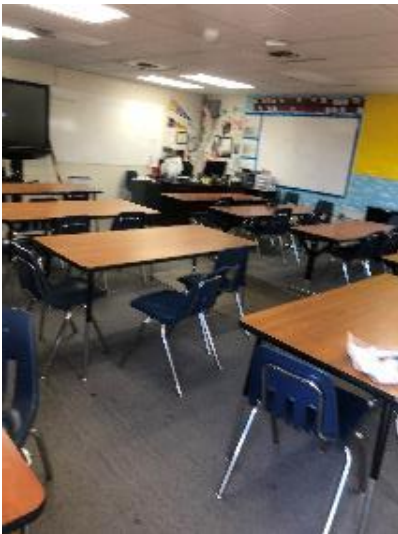
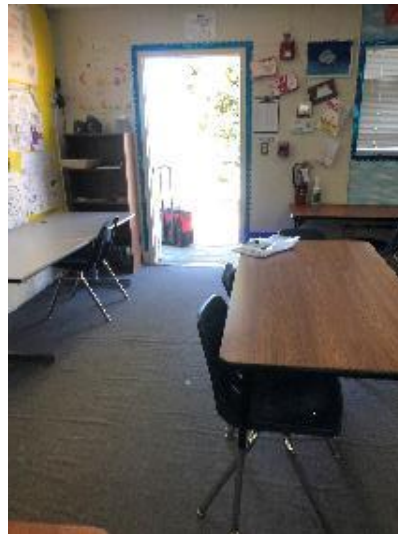
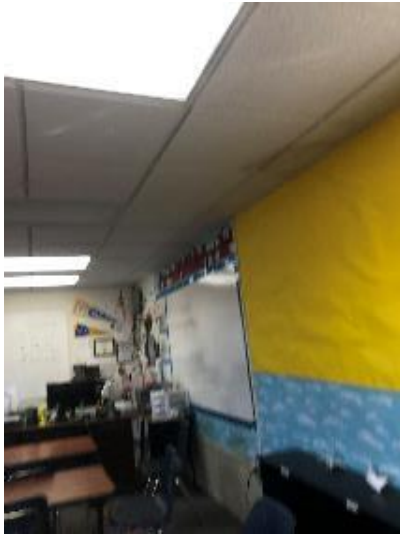
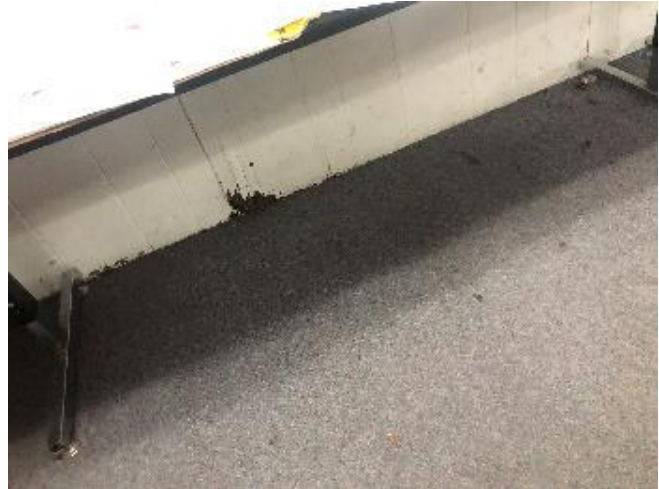
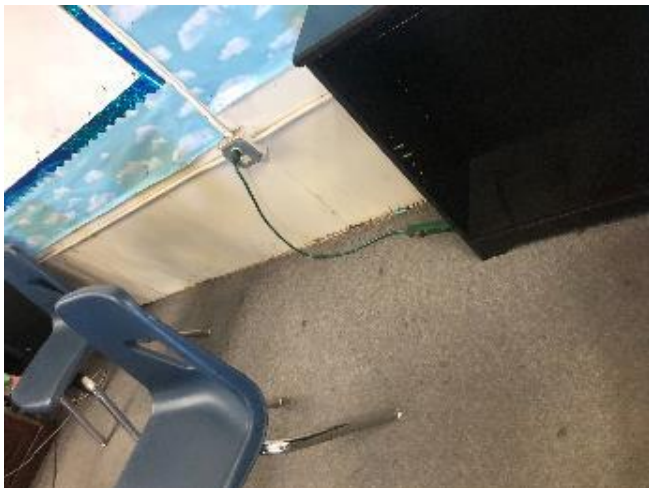
**Location #13 - Photographs**

-Visible water damage found on ceiling tiles.  
-Suspect mold growth and visible water damage found on back, right and front wall. Precautionary surface samples taken to determine possible contamination.

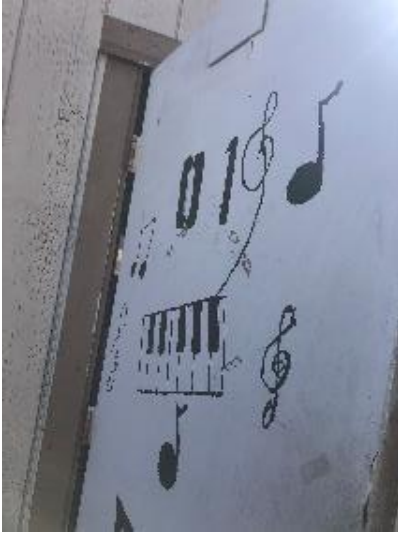
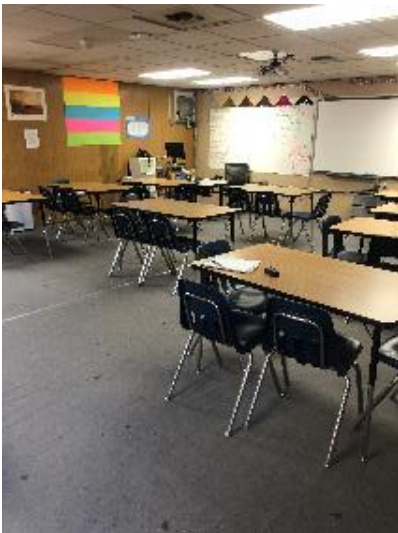
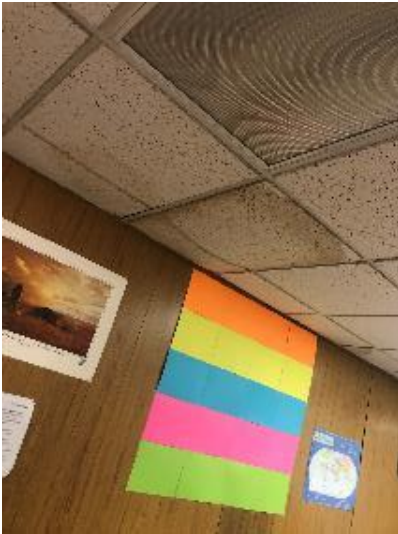
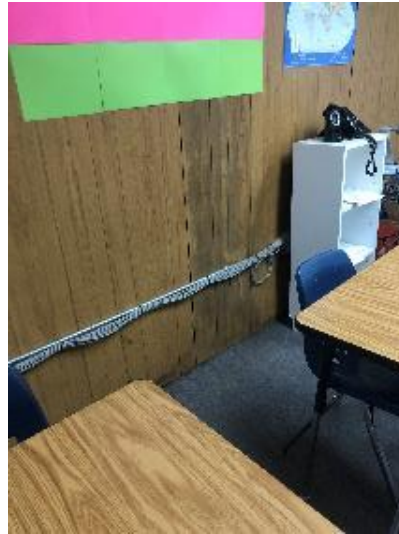
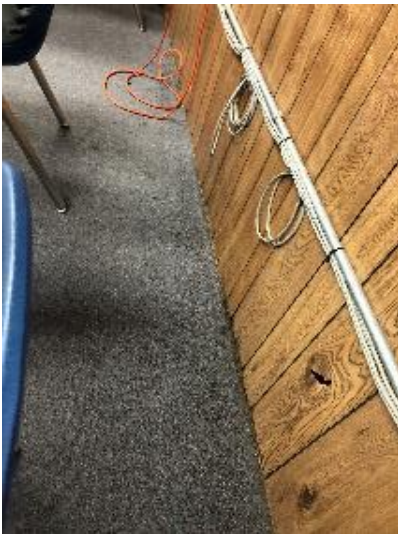
**Location #14 - Photographs**

- Visible water damage found on ceiling.
- Suspect mold growth and visible water damage found left and front wall. Precautionary surface samples taken to determine possible contamination.
- Suspect mold growth and visible water damage found on back wall.

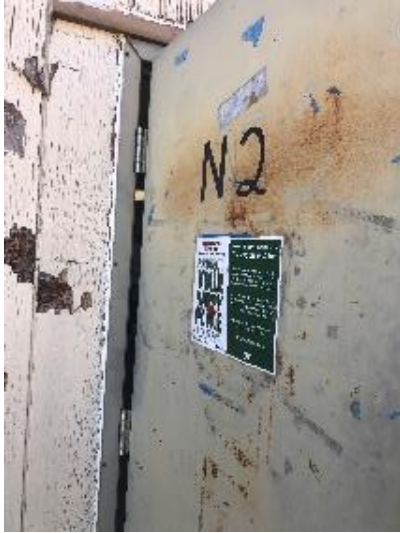
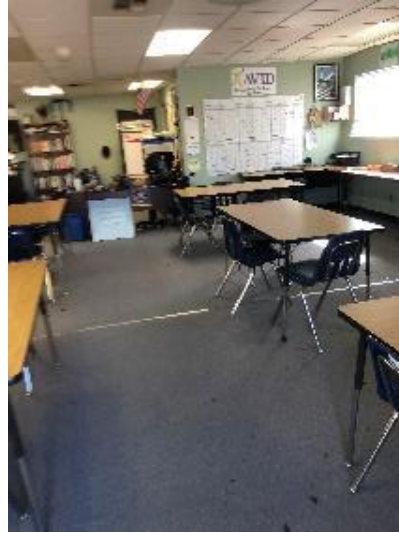
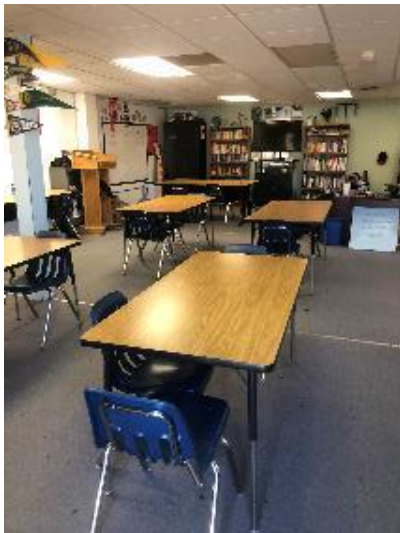
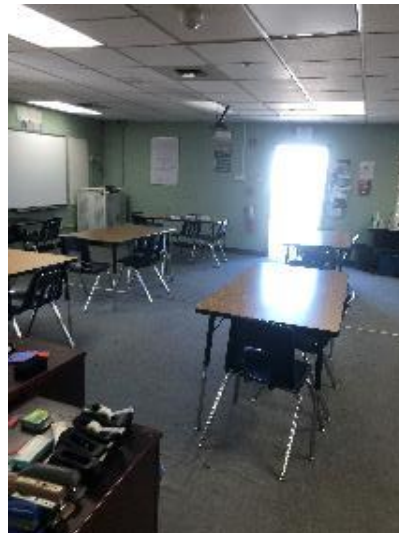
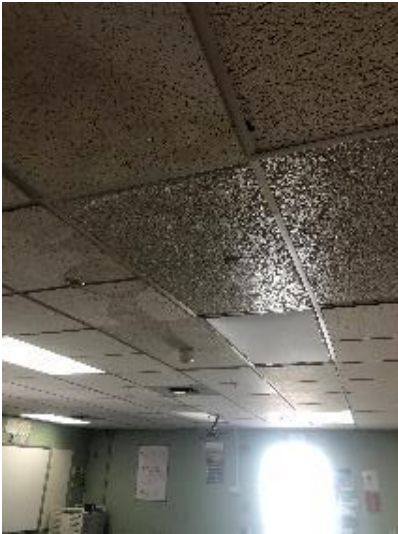
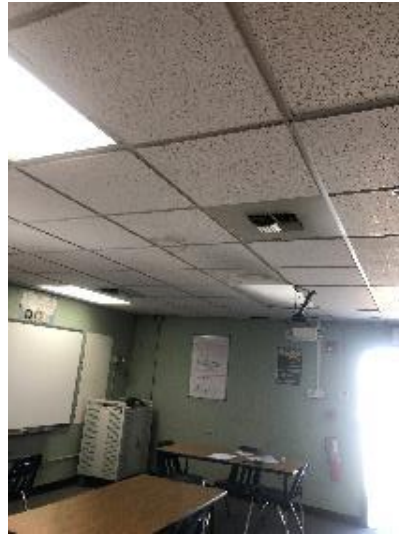
**Location #15 - Photographs**

-Suspect mold growth and visible water damage found on ceiling tiles. Precautionary surface samples taken to determine possible contamination.

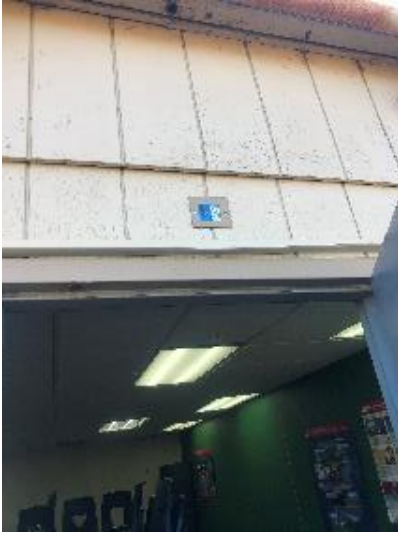
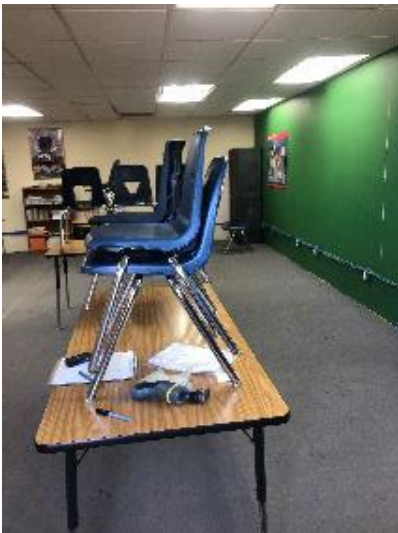
**Location #16 - Photographs**

-Visible water damage found on ceiling tiles. Precautionary surface samples taken to determine possible contamination.

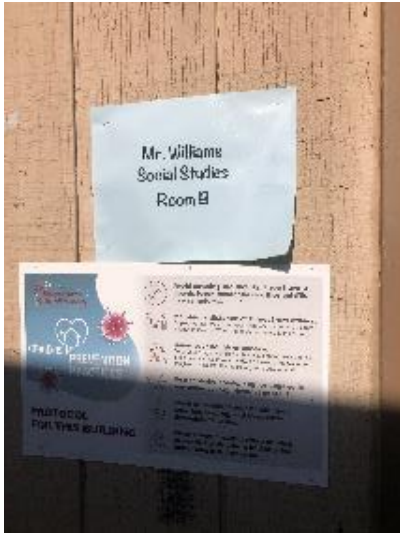
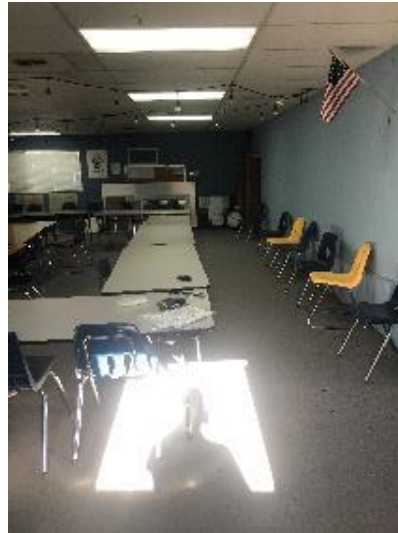
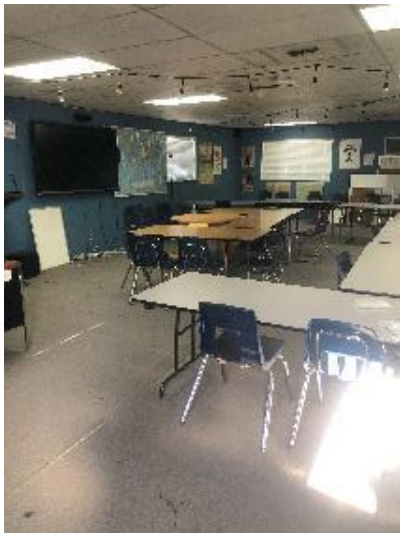
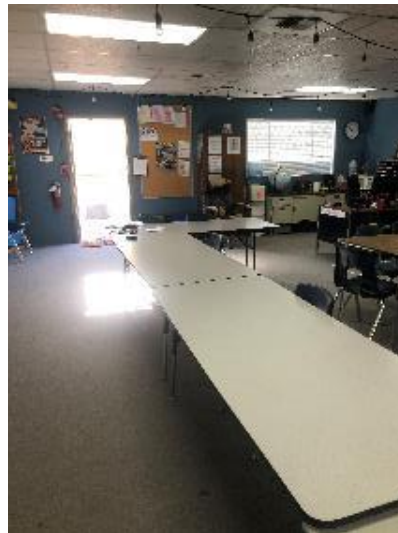
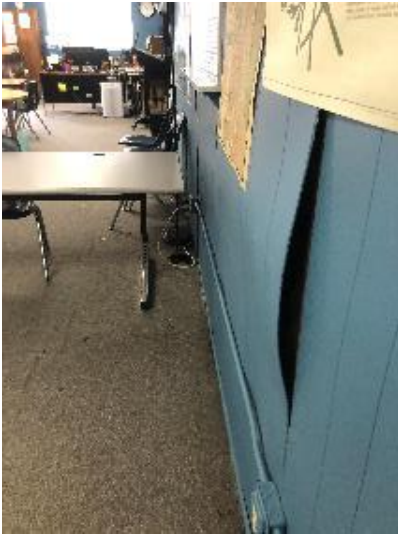
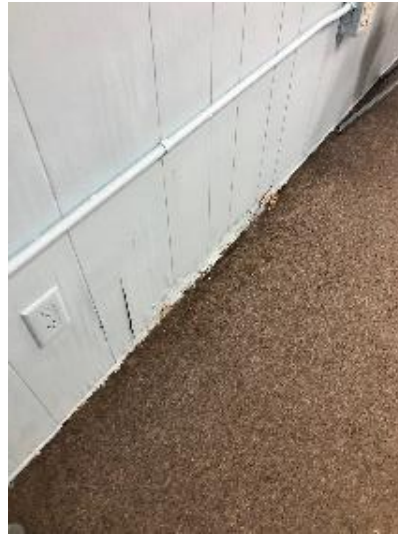
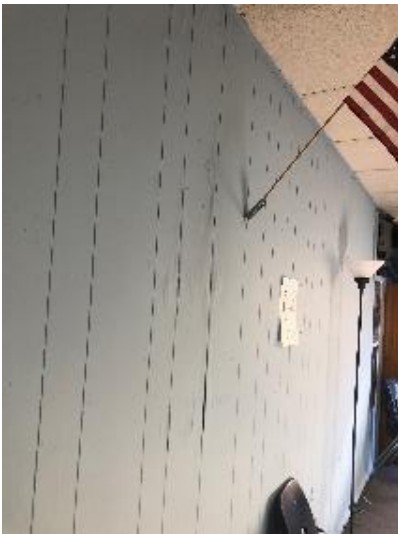
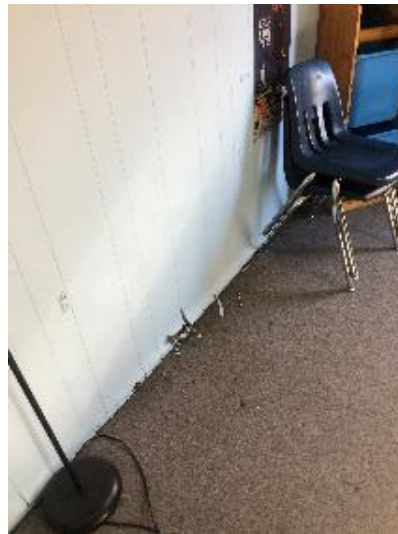
- Visible water damage found on ceiling tiles.
- Suspect mold growth and visible water damage found on left and right wall. Precautionary surface samples taken to determine possible contamination.

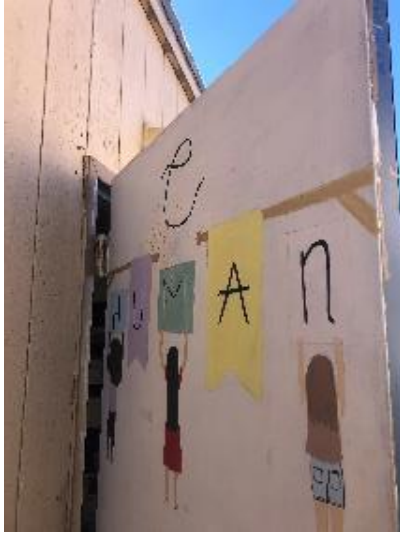
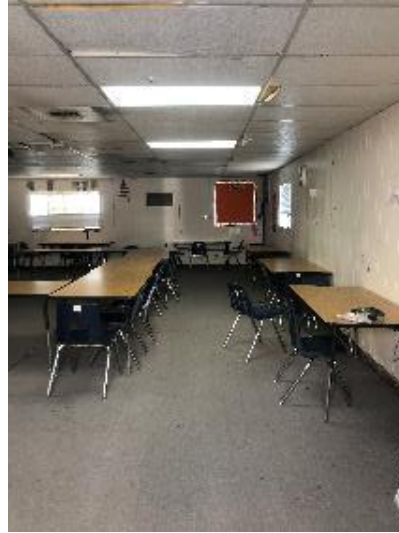
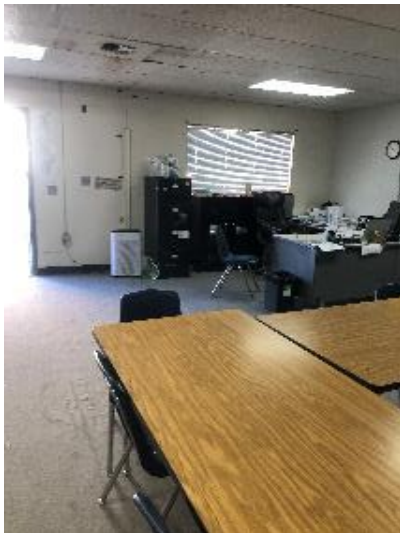
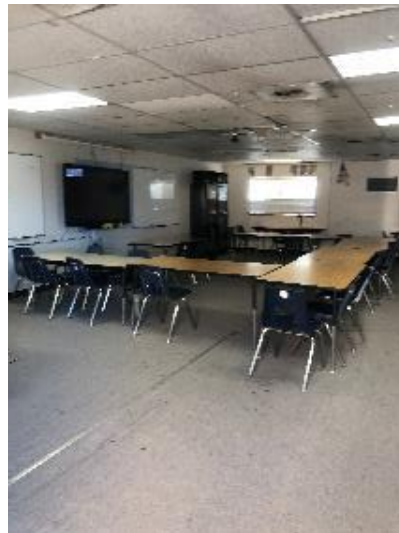
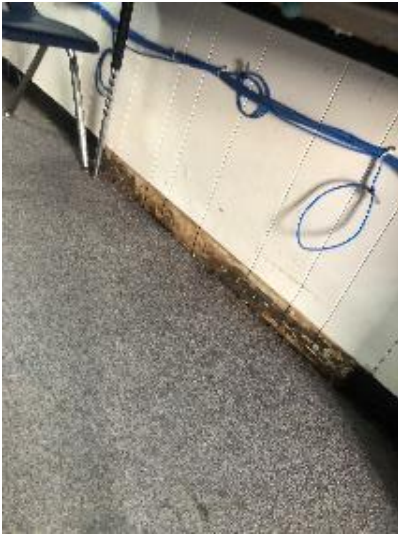
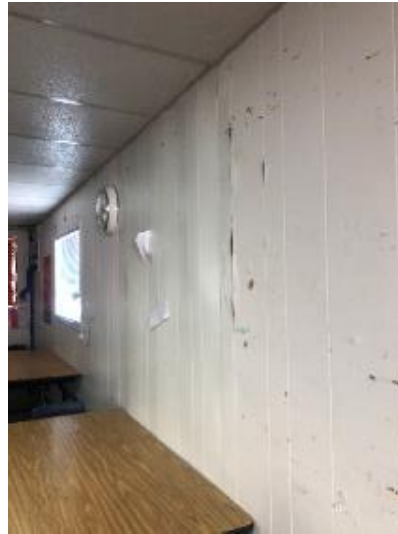
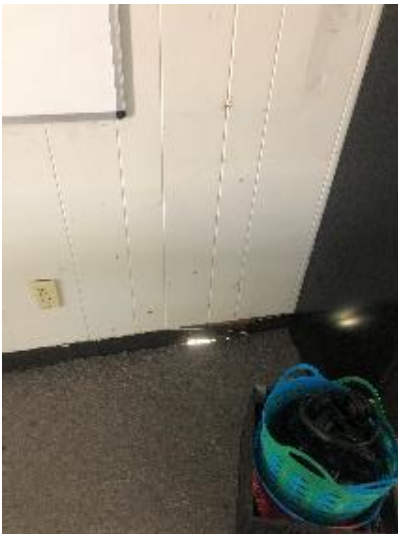
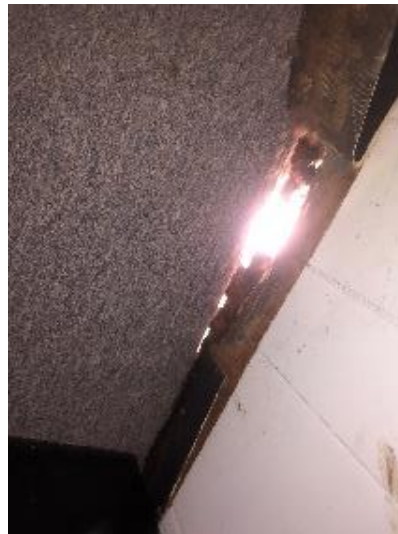
- Suspect mold growth and visible water damage found on right wall. Precautionary surface samples taken to determine possible contamination.
- Visible water damage found on left wall.

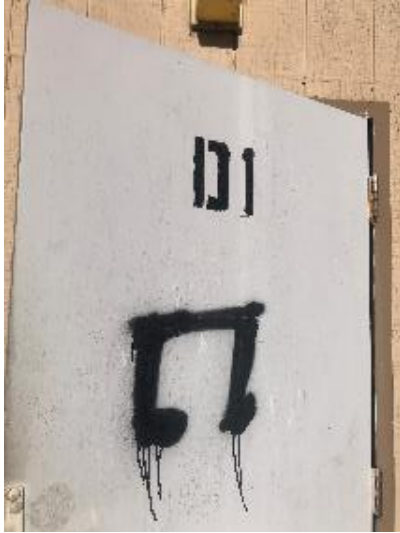
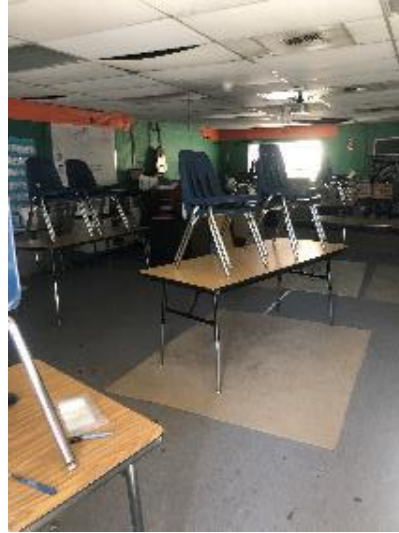
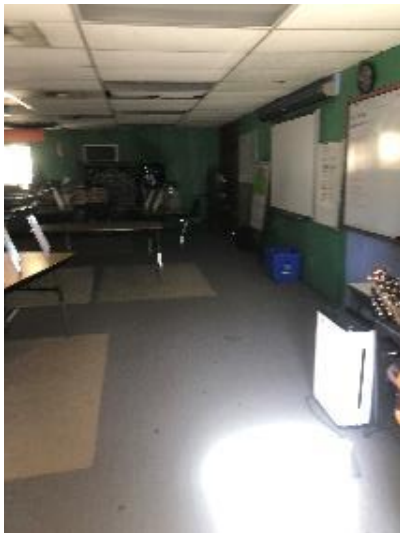
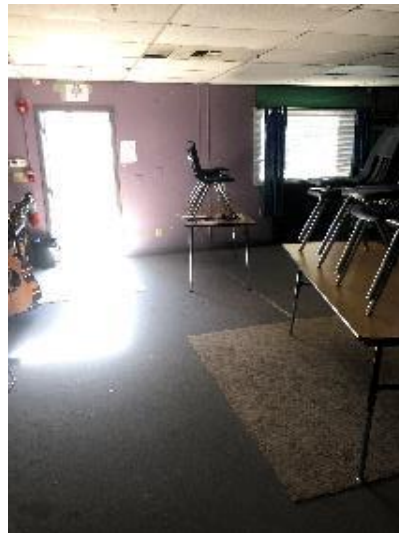
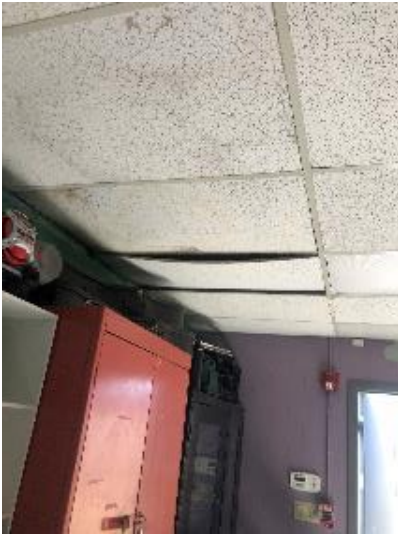
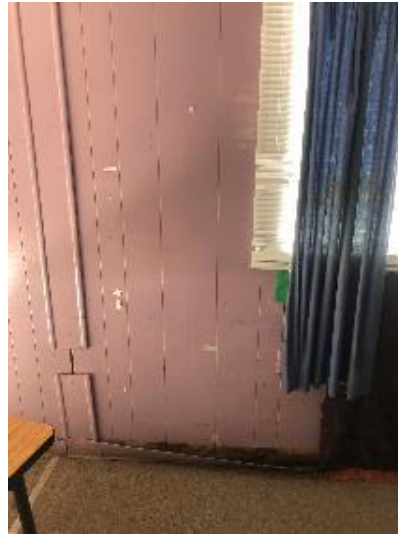
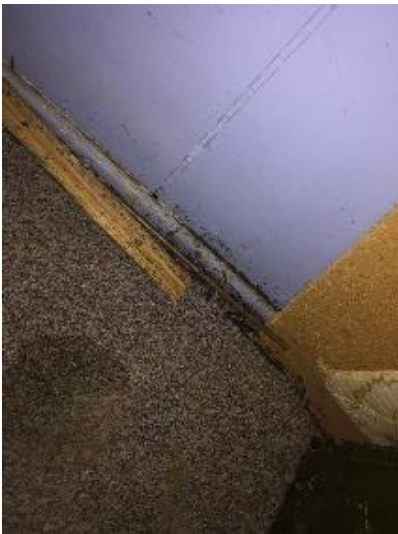
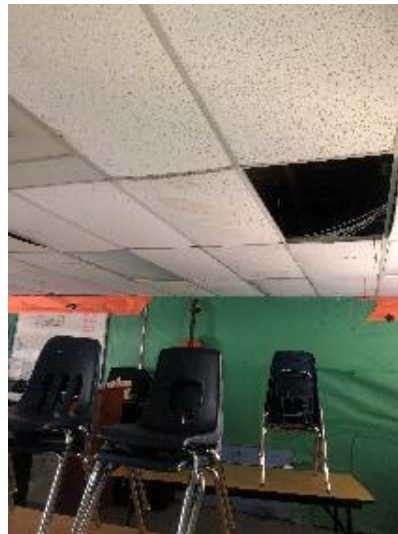
- Visible water damage found on ceiling tiles.
- Suspect mold growth and visible water damage found on left and right wall. Precautionary surface samples taken to determine possible contamination.
- Visible water damage found on front wall.

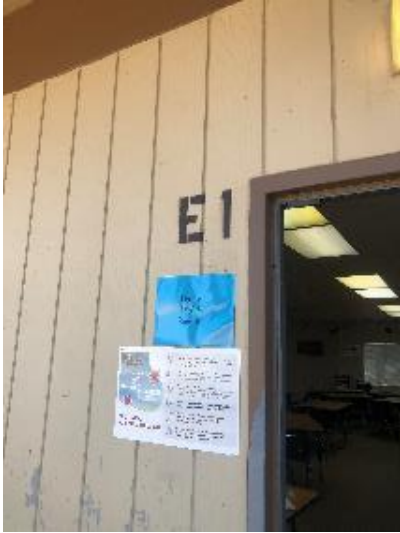
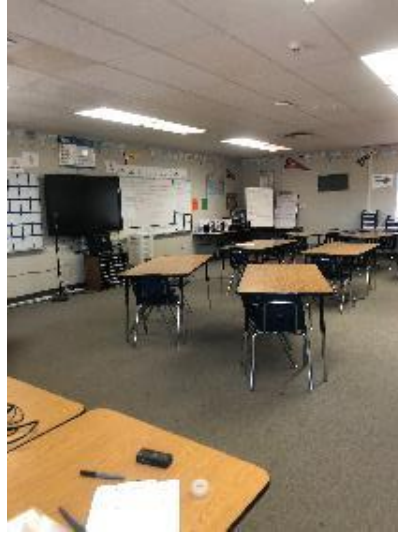
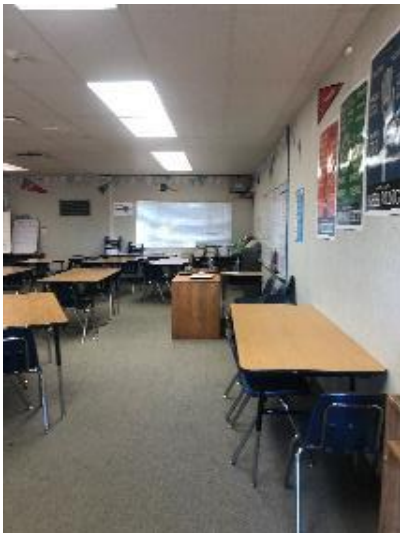
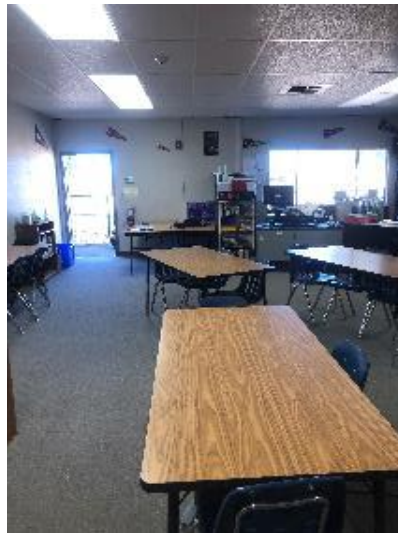
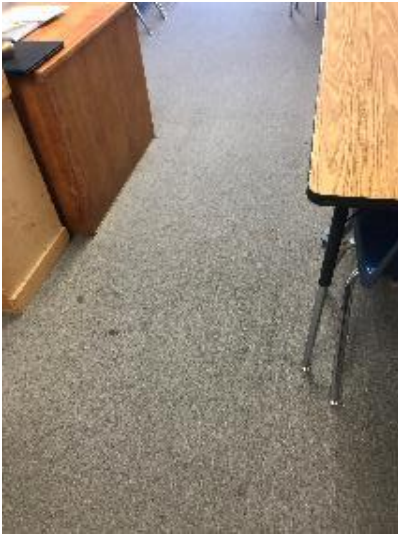
No visible suspect mold growth or elevated moisture found at the time of inspection. Precautionary surface samples taken to determine possible contamination.

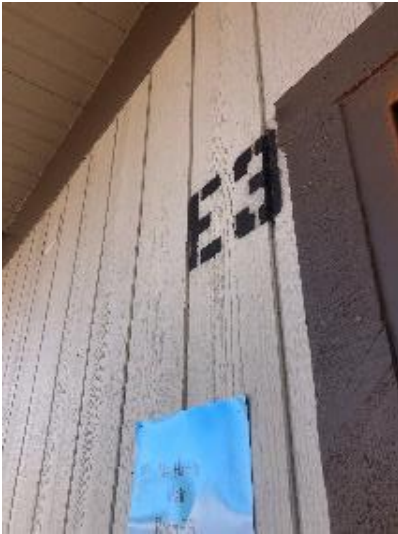
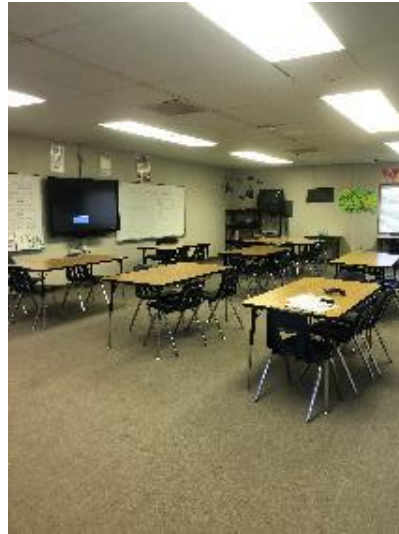
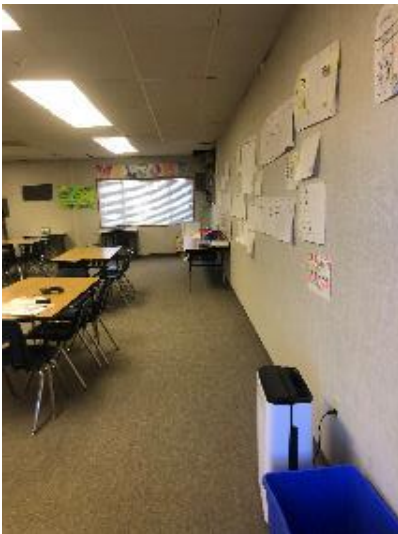
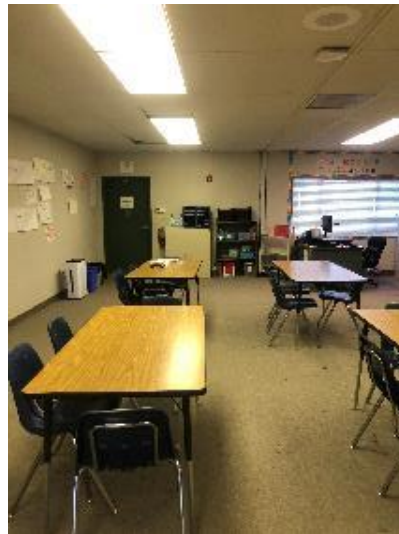
**Location #23 - Photographs**

- Visible water damage found on various areas of ceiling tiles.
- Suspect mold growth and visible water damage found on front wall. Precautionary surface samples taken to determine possible contamination.
- Suspect mold growth and visible water damage found on back wall.
- Visible water damage found around window frames.

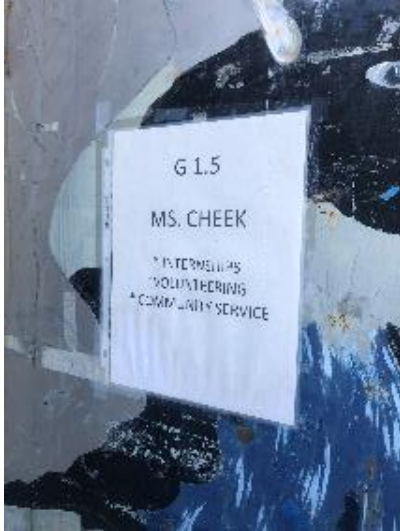
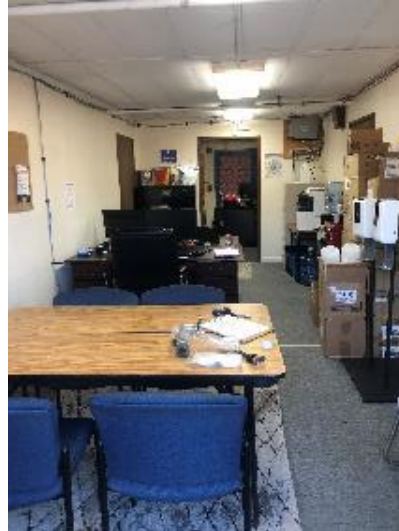
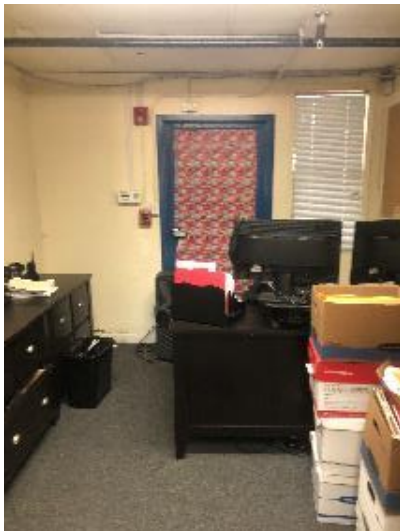
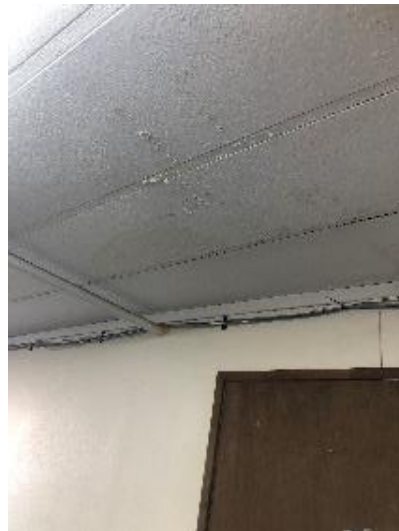
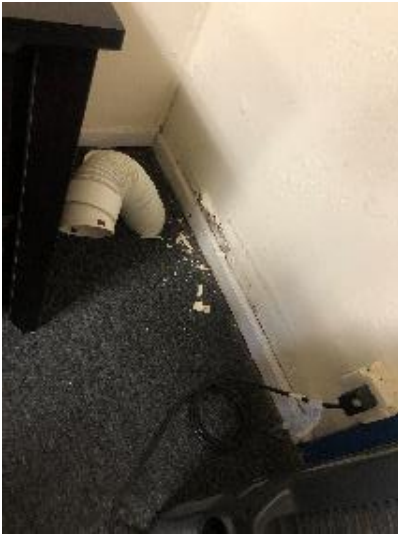
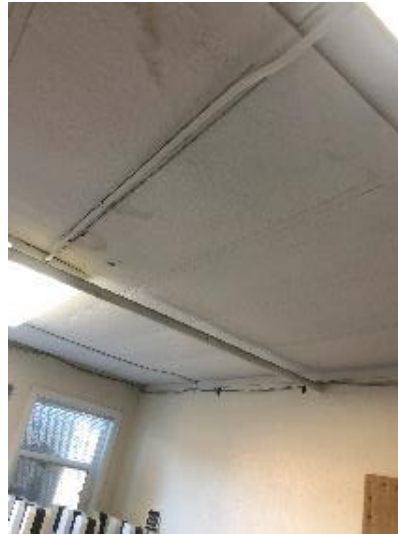
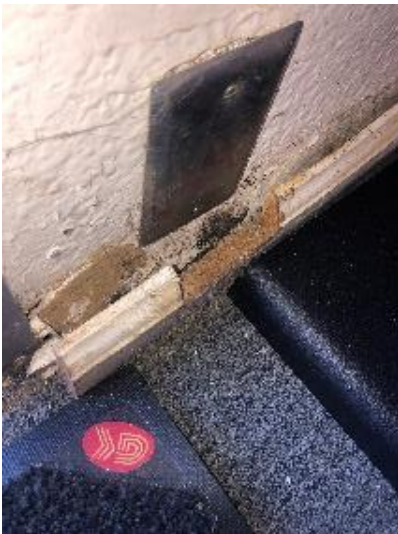
**Location #25 - Photographs**

- Suspect mold growth and visible water damage found on back wall. Precautionary surface sample taken to determine possible contamination.
- Suspect mold growth and visible water damage found around window frames.
- Suspect mold growth and visible water damage found on front wall.
- Visible water damage found on right wall.
- Suspect mold growth and visible water damage found around window frames.
- Visible water damage found on ceiling tiles.
