**Attachment to Funding Determination Request**

**Narrative Responses to Section IV, Questions 1, 2, 3**

# Mold Inspection Report

## Microbial Investigation

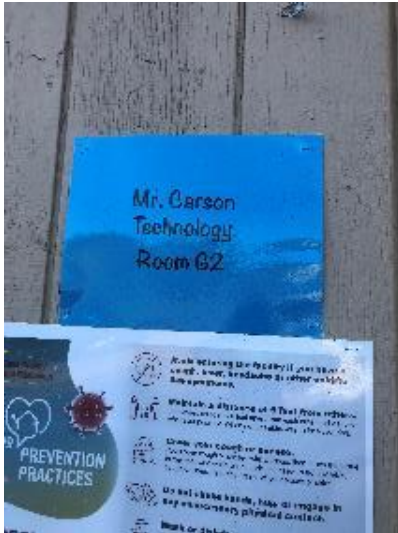
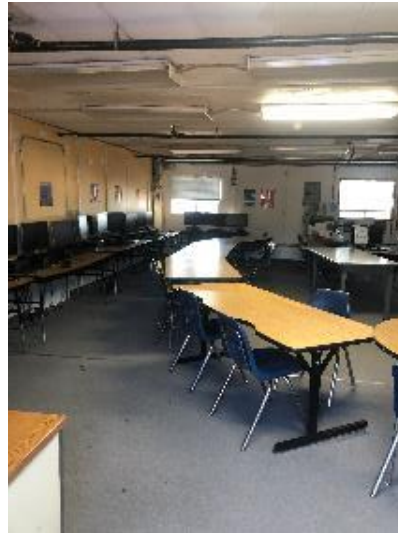
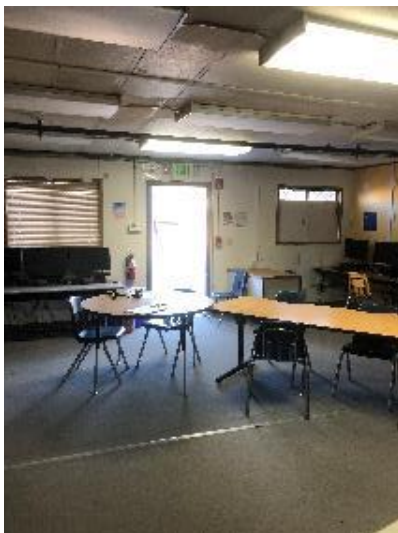
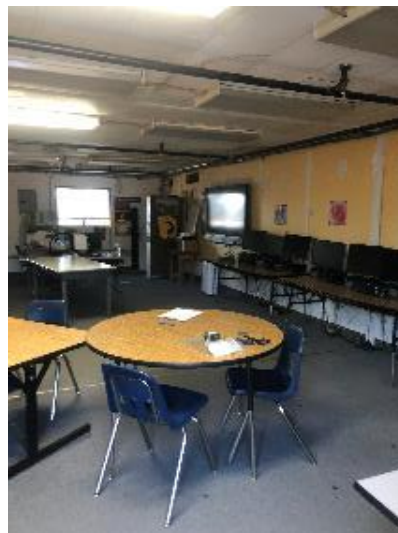
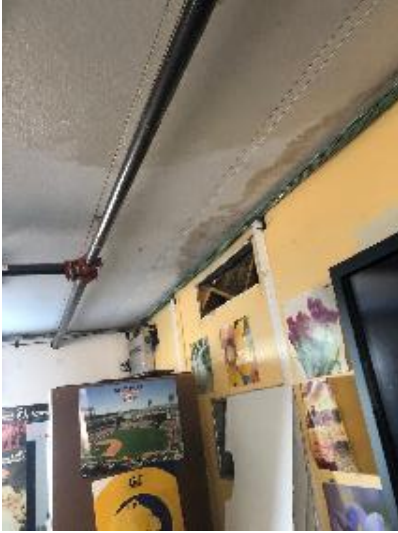
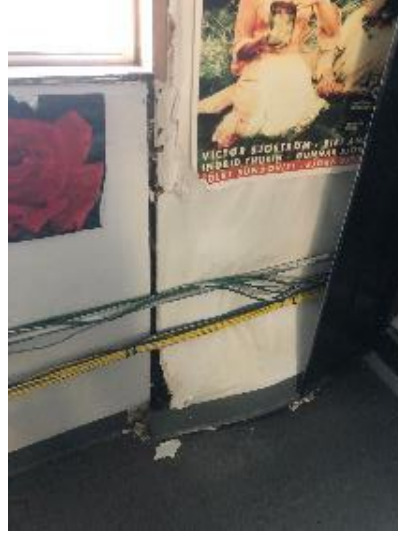
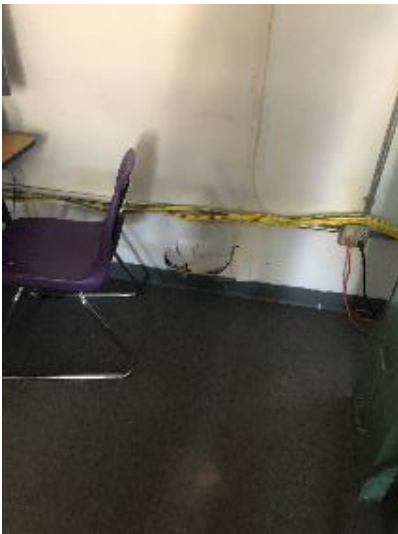
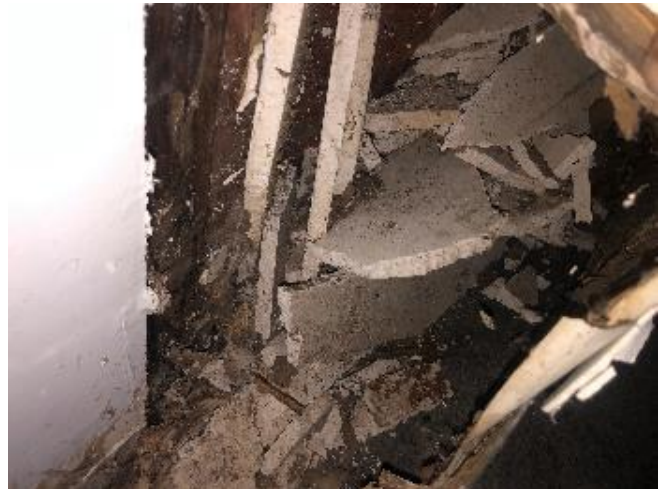
**Location #26 - Photographs**

-Suspect mold growth and visible water damage found on ceiling tiles. Precautionary surface samples taken to determine possible contamination.

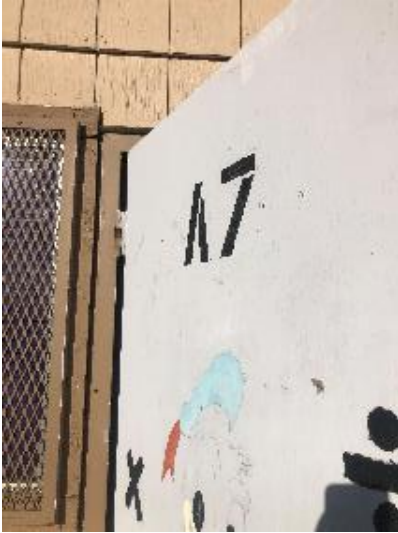
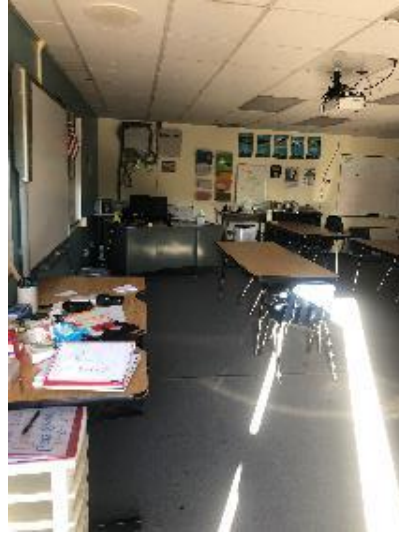
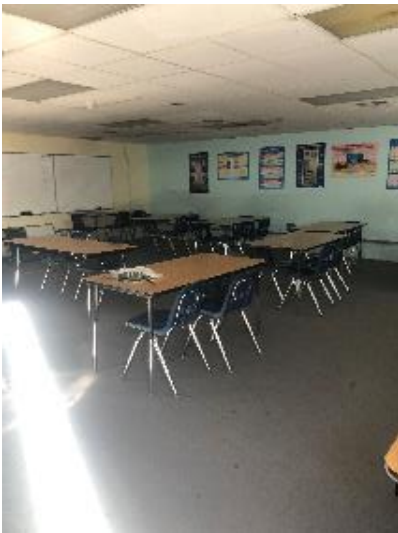
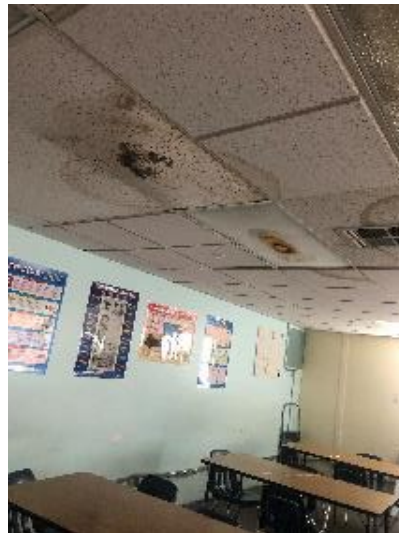
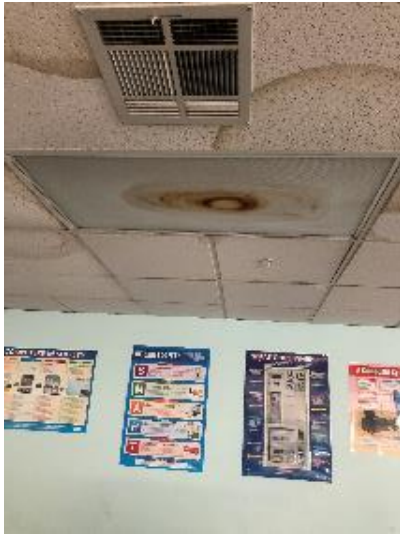
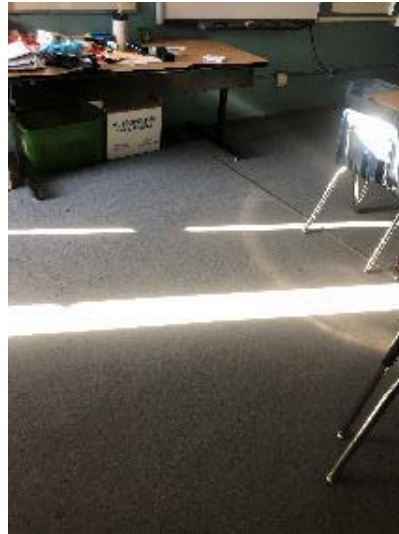
**Location #27 - Photographs**

Visible water damage found on ceiling. Precautionary surface sample taken to determine possible contamination.

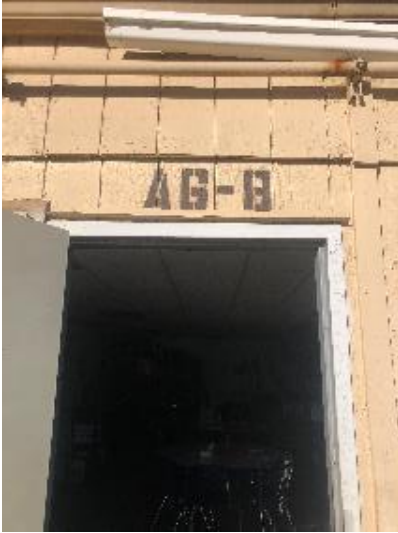
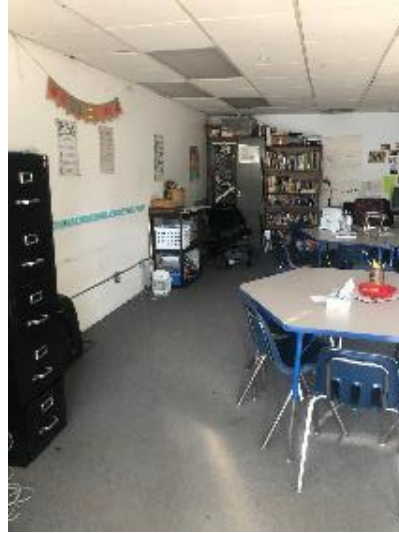
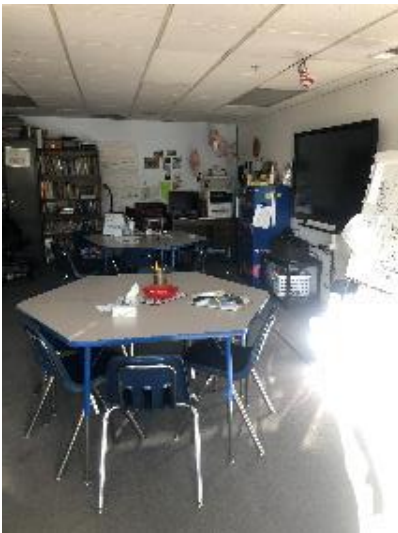
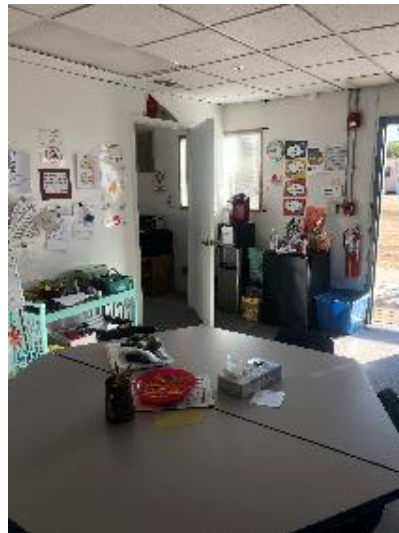
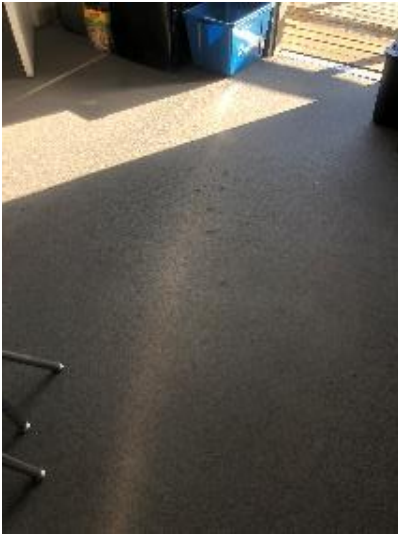
**Location #28 - Photographs**

-Visible water damage found on ceiling. Precautionary surface sample taken to determine possible contamination.
